AMETI, AUCKLAND WSUD WALK

Activating WSUD Project
Building better homes towns and cities science challenge

AMETI WSUD walks

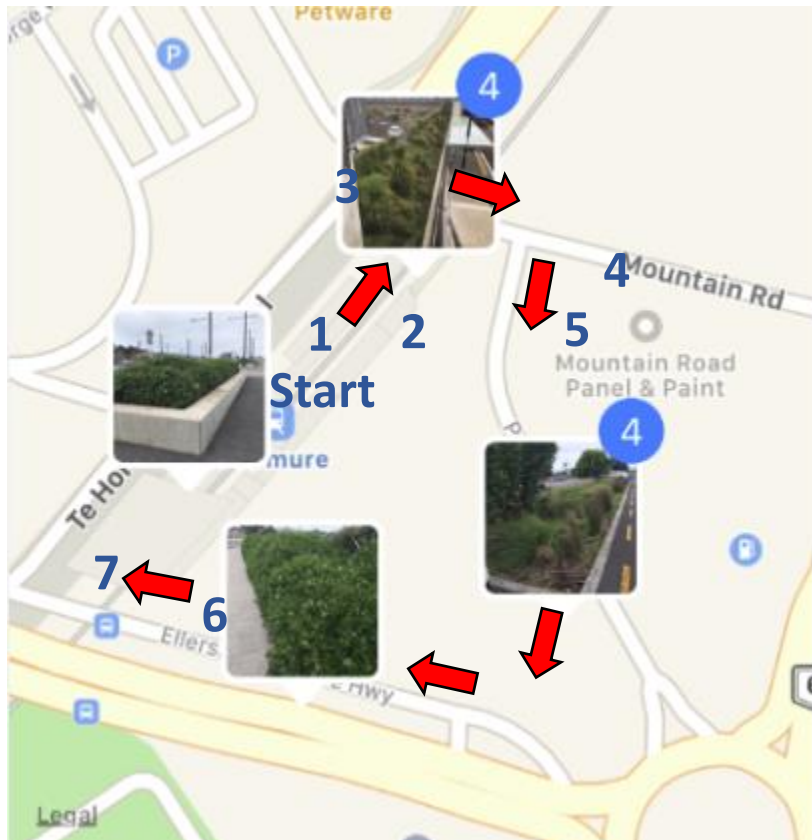
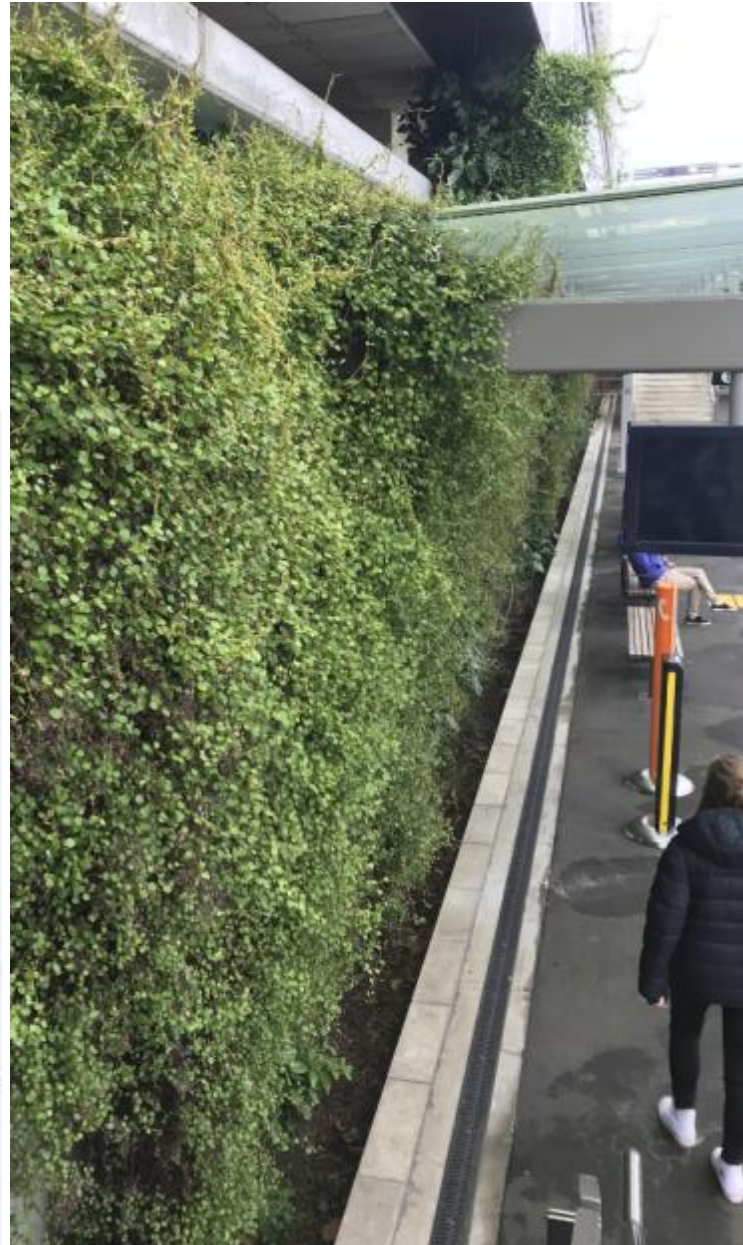
Site 1. Stormwater planter green screen

Lava geological feature

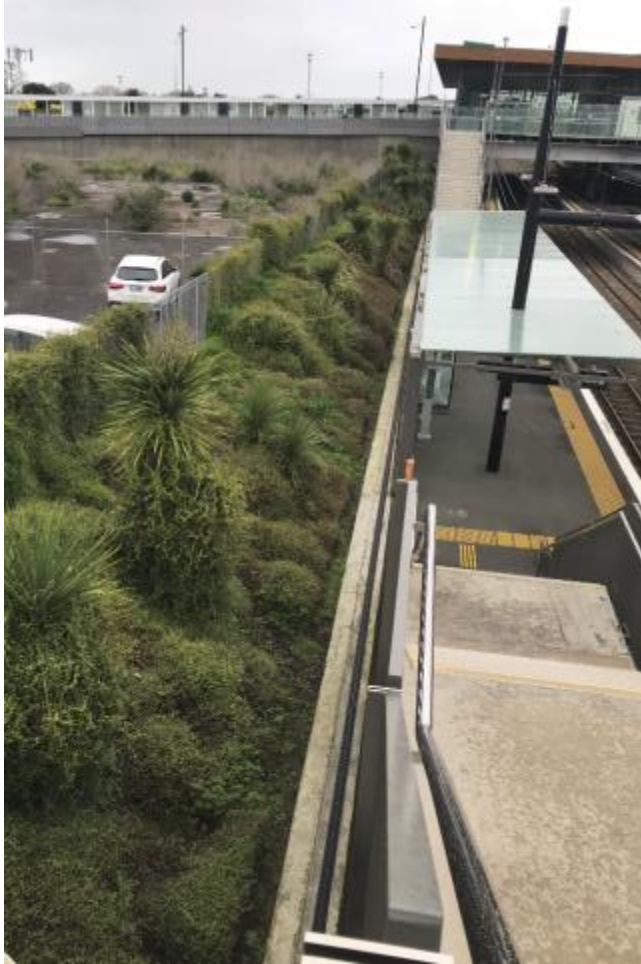
Site 2. Conventional planting by train platform screens adjacent wasteland

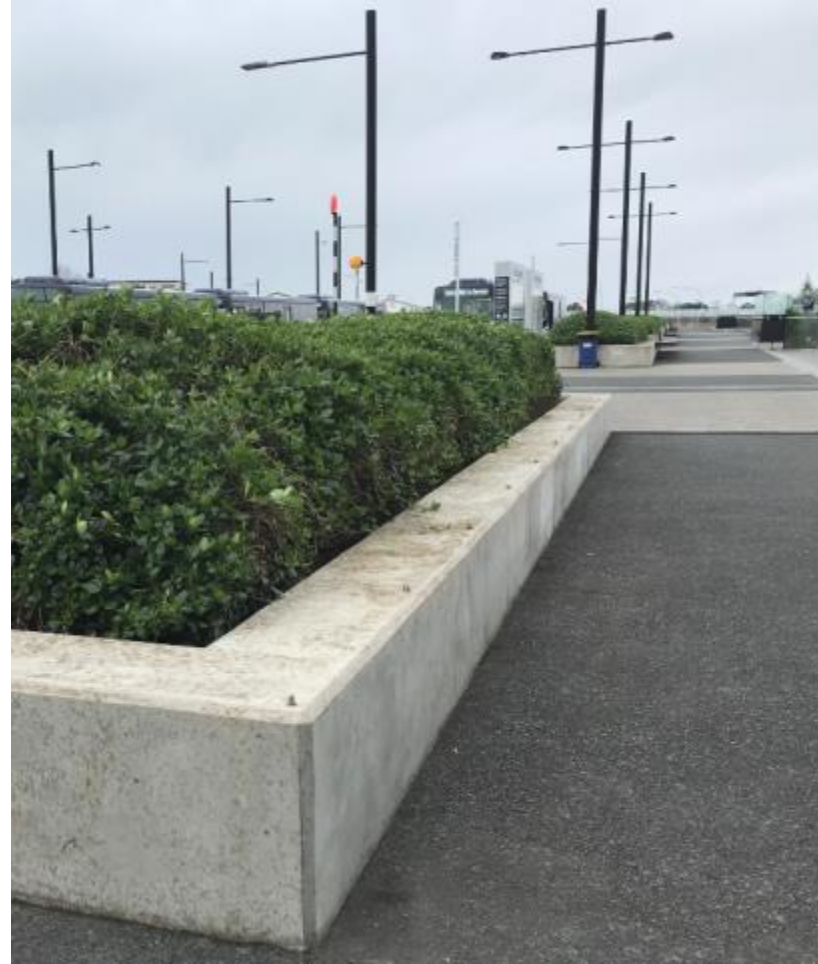
Site 2. Raised roadside planters on Quinlan Street do not receive stormwater so require irrigation (and its maintenance). Trimming at ground level (right) reduces weed invasion and litter input but prevents seating.

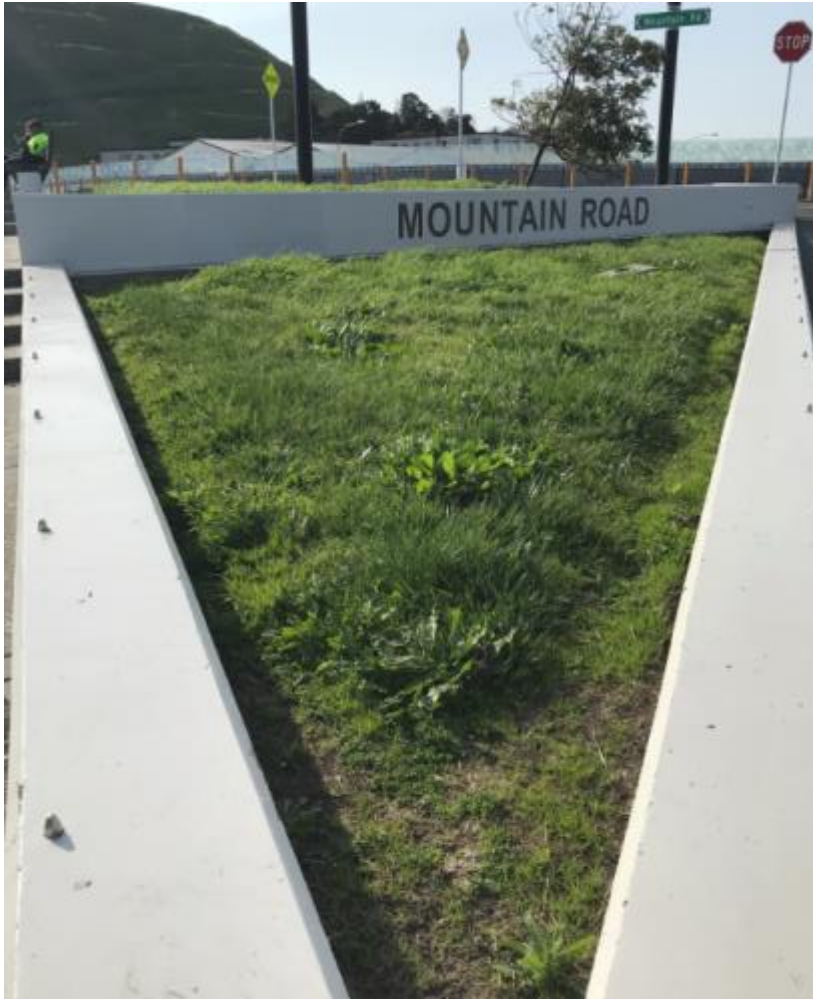
- 2 – **Conventional roadside planters** separate commuters from traffic and soften hard-scape; edges are seats with suitable plant trimming
- 3 – Mana whenua identified in terrace inscriptions. Costly maintenance of grassed terraces due to shape, poor access and up-lights in grass. Trees have died, remnant tree is ringbarked by weed-eater.

Site 3. Raised, unevenly-shaped, grassed terraces with up-lights are costly to maintain due to difficult access

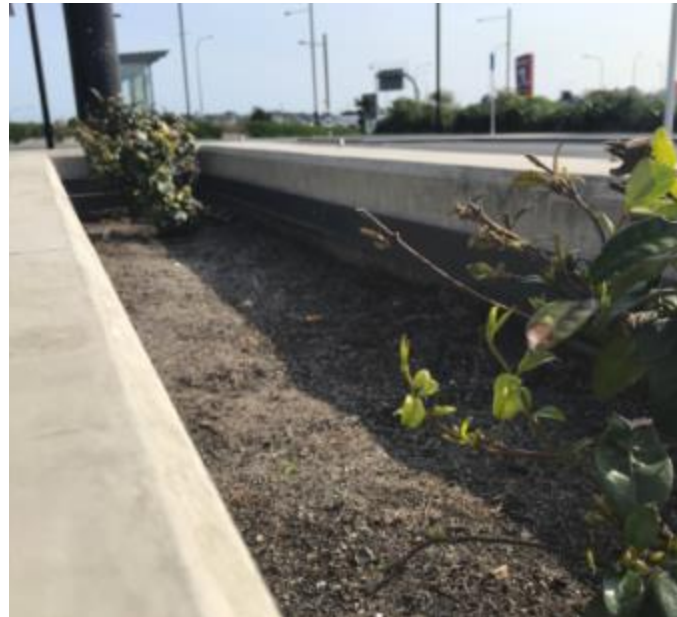
Site 2. Plants in narrow, raised planter boxes have died and need replacing with new mulching

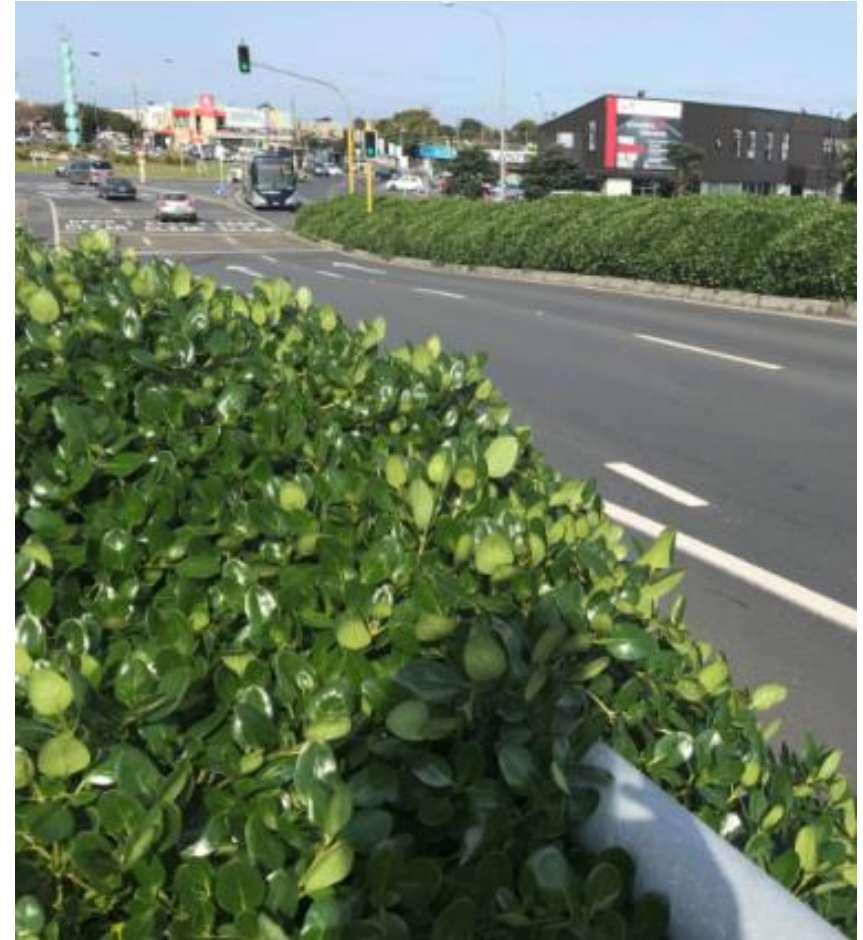
- 6 – **Tree pits in Bus station overbridge with poured permeable paving**; Road median barrier of raised planters effective visually but costly to maintain and dead areas have not been replanted or mulched, so require continual spraying

Site 2. Raised planters in the Ellerslie Highway median need traffic closure to trim but add high amenity and reduce headlight glare

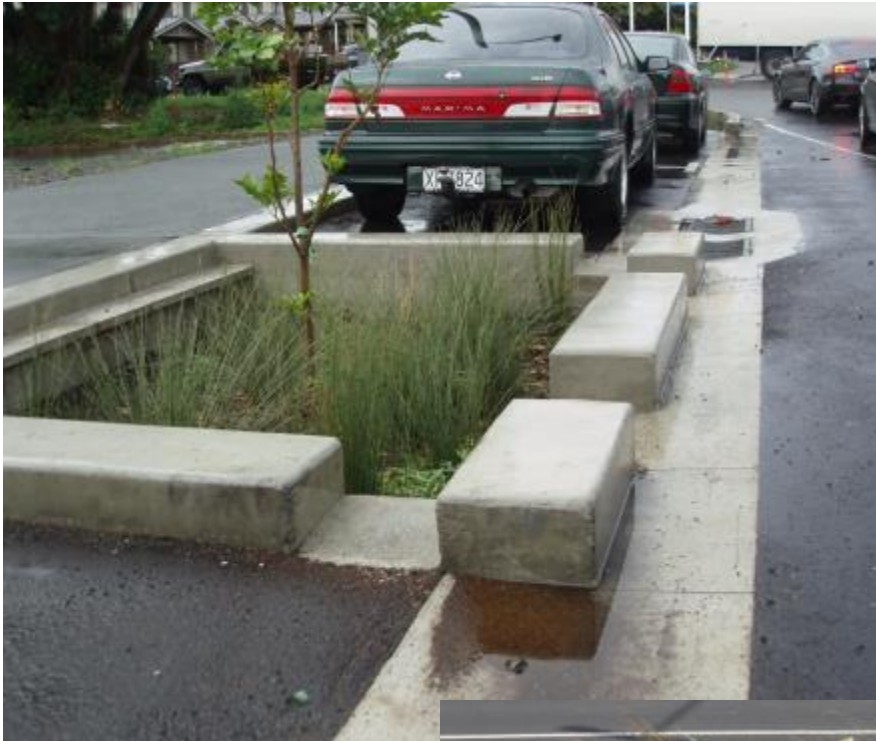
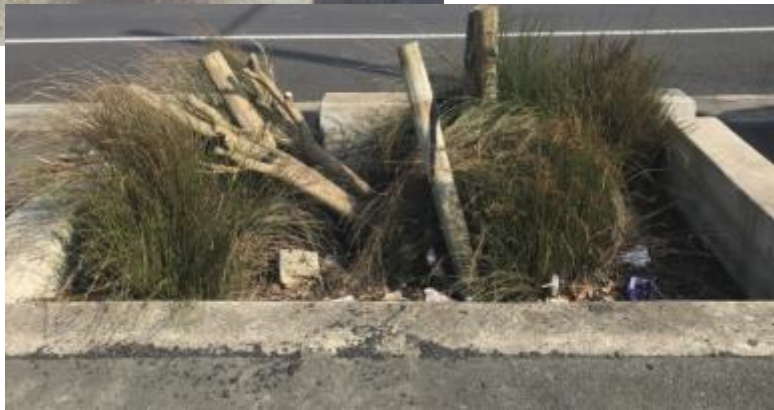
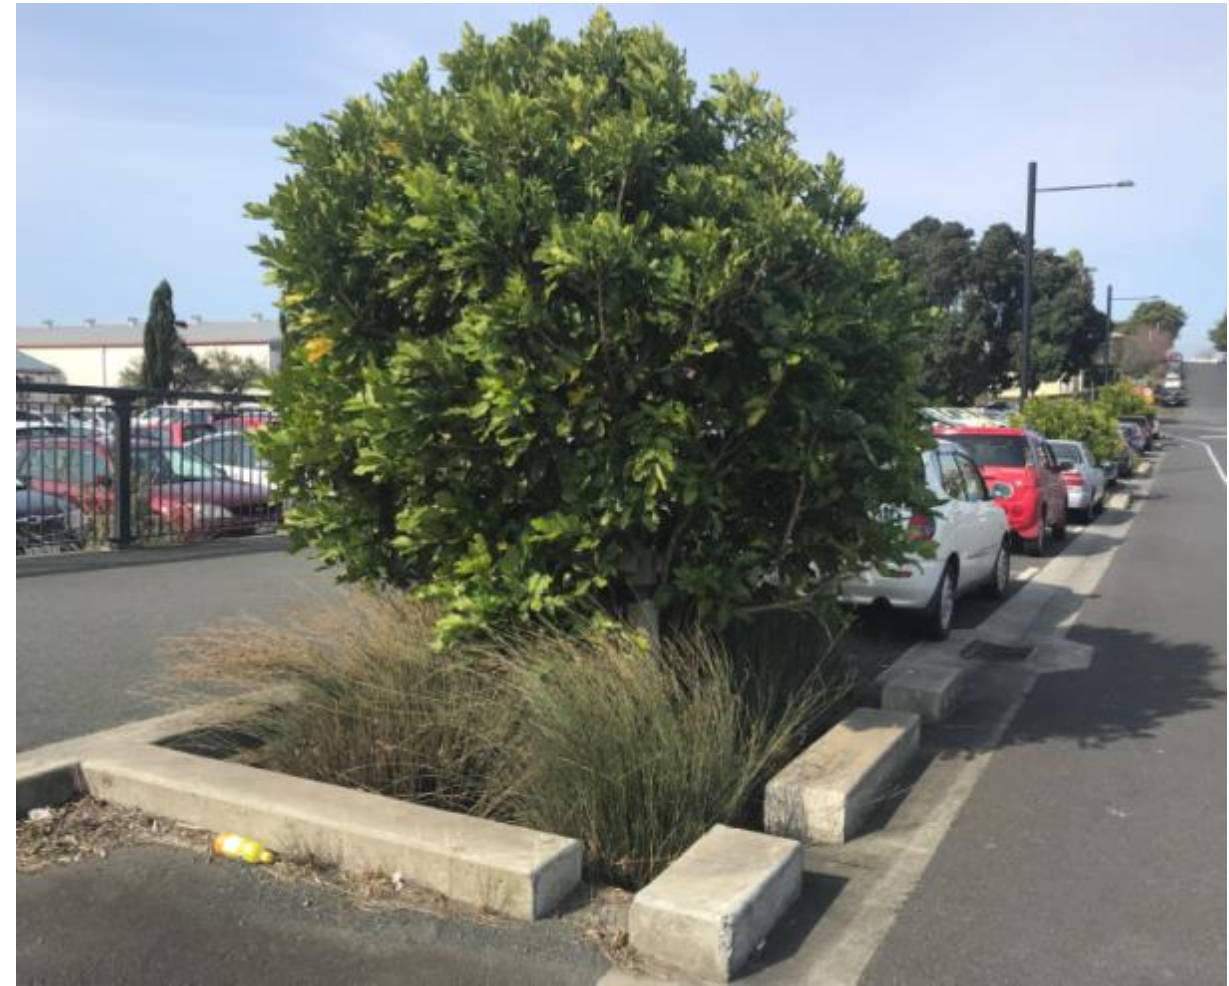
Potaka Lane: site 4

2017 (dead tree)

Site 4. Potaka Lane roadside tree pits with oioi groundcover and kohekohe trees shortly after establishment in 2013 and in late 2018

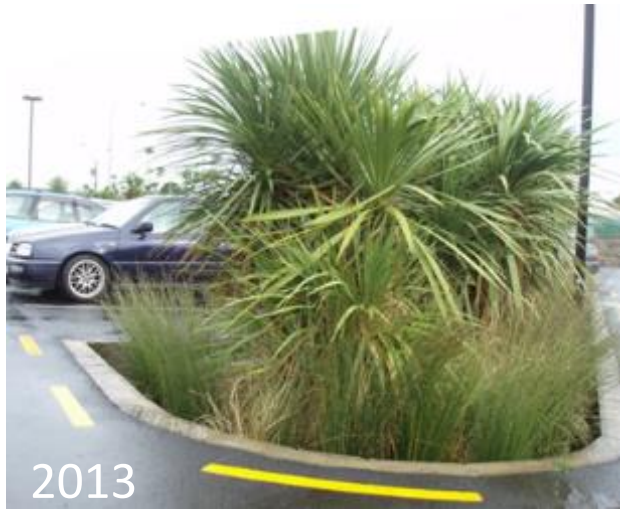
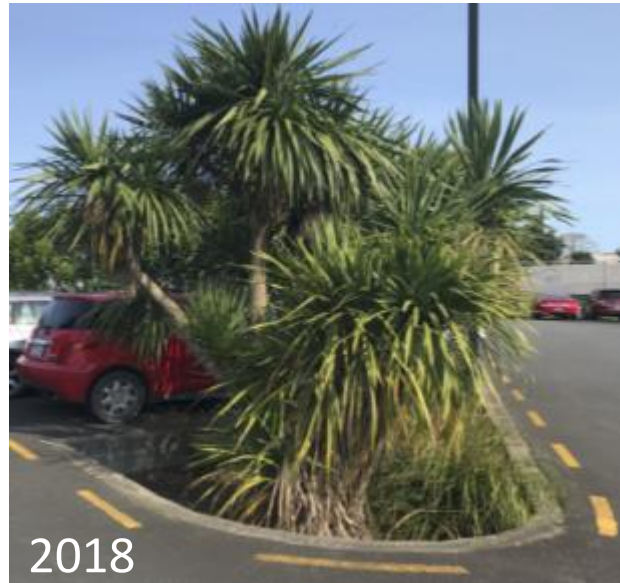
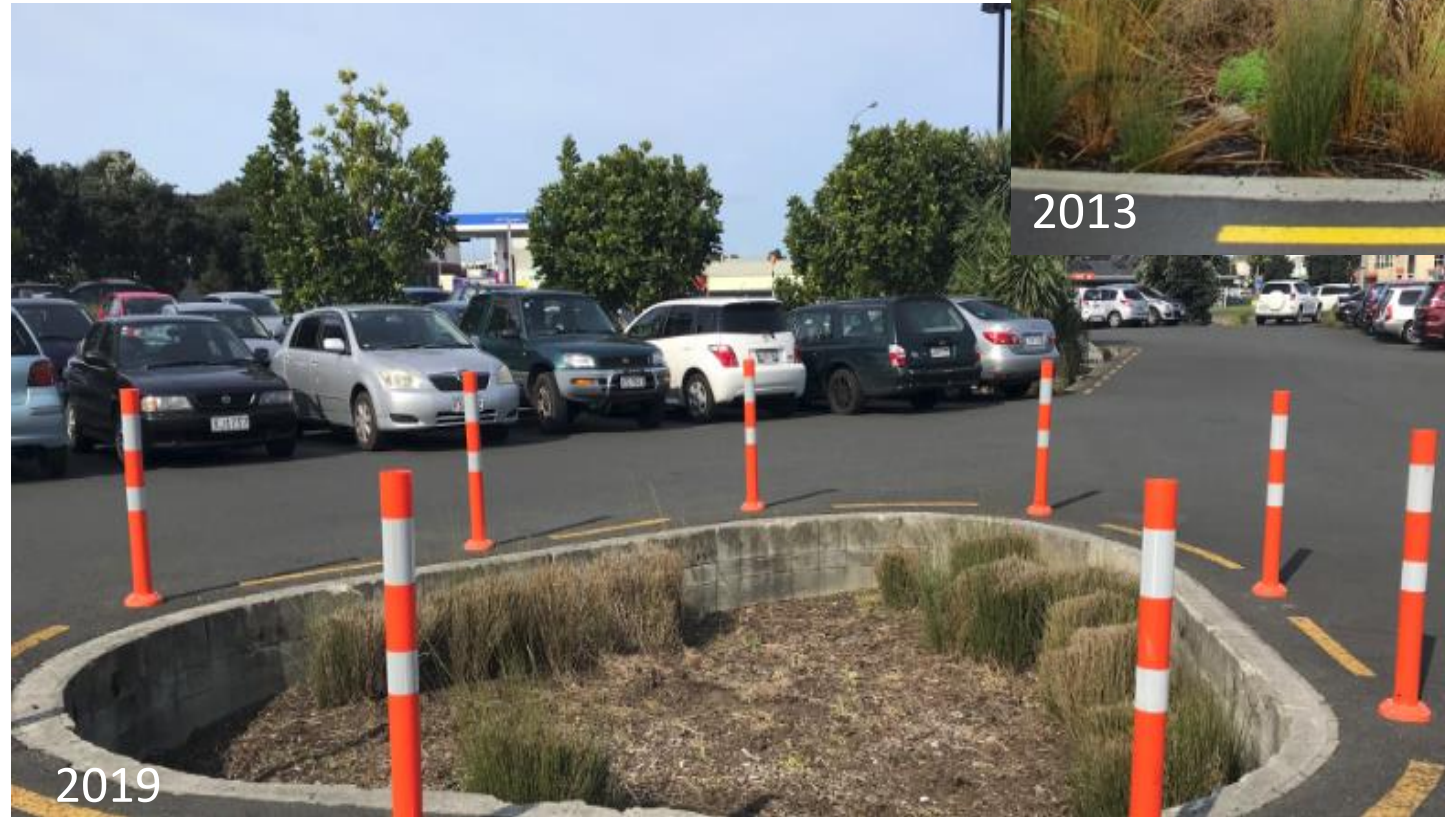
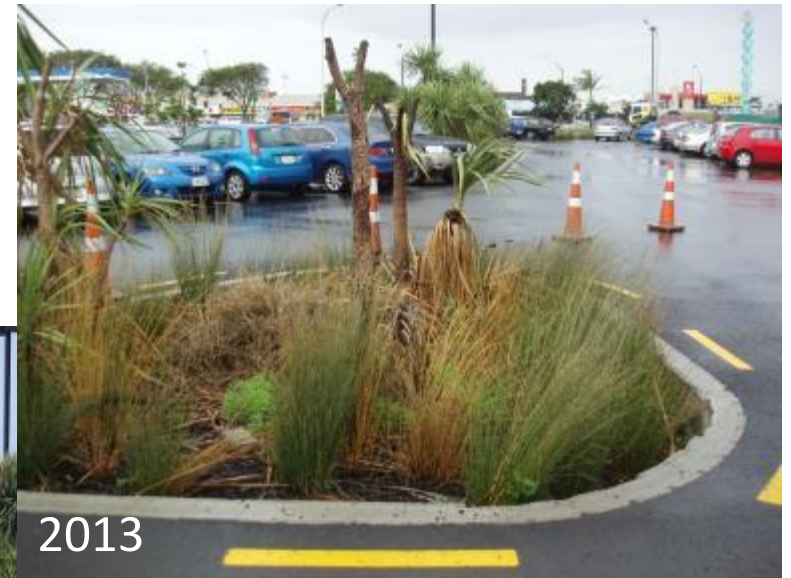
Panmure park and ride raingardens: site 5

Site 5. Raingarden shape and location influence vulnerability of edges and trees to vehicle damage. The roundabout is vulnerable although identifying the edge with contrasting edge colour helps. Really ugly retrofit of warning stakes and inadequate groundcover.

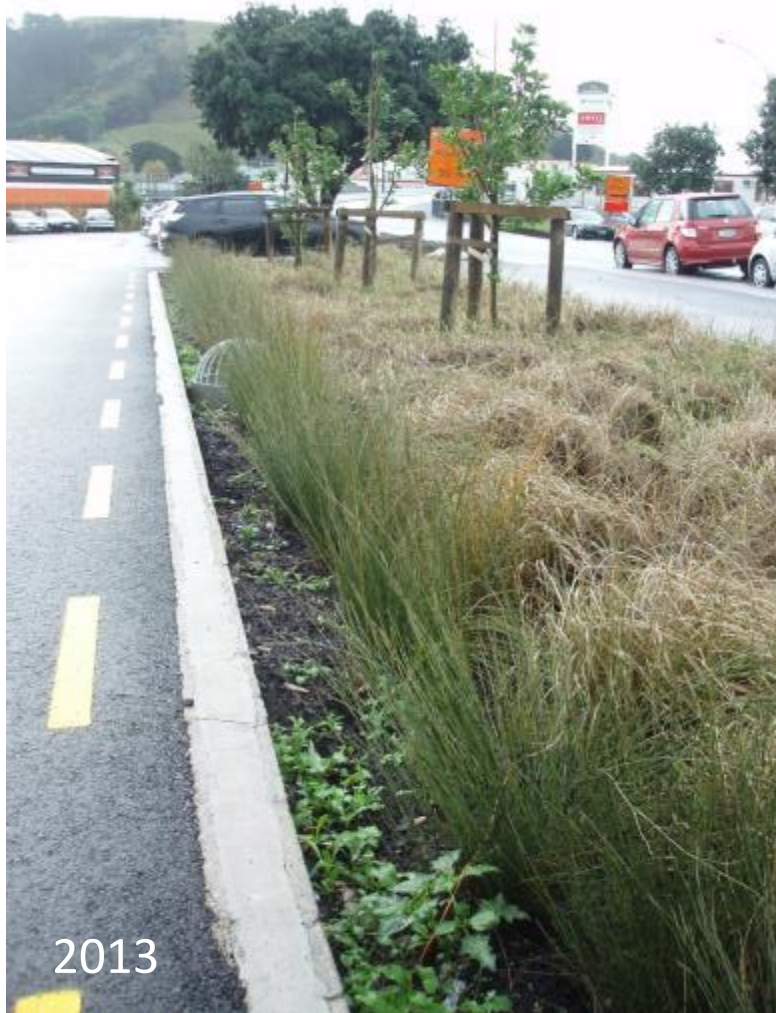
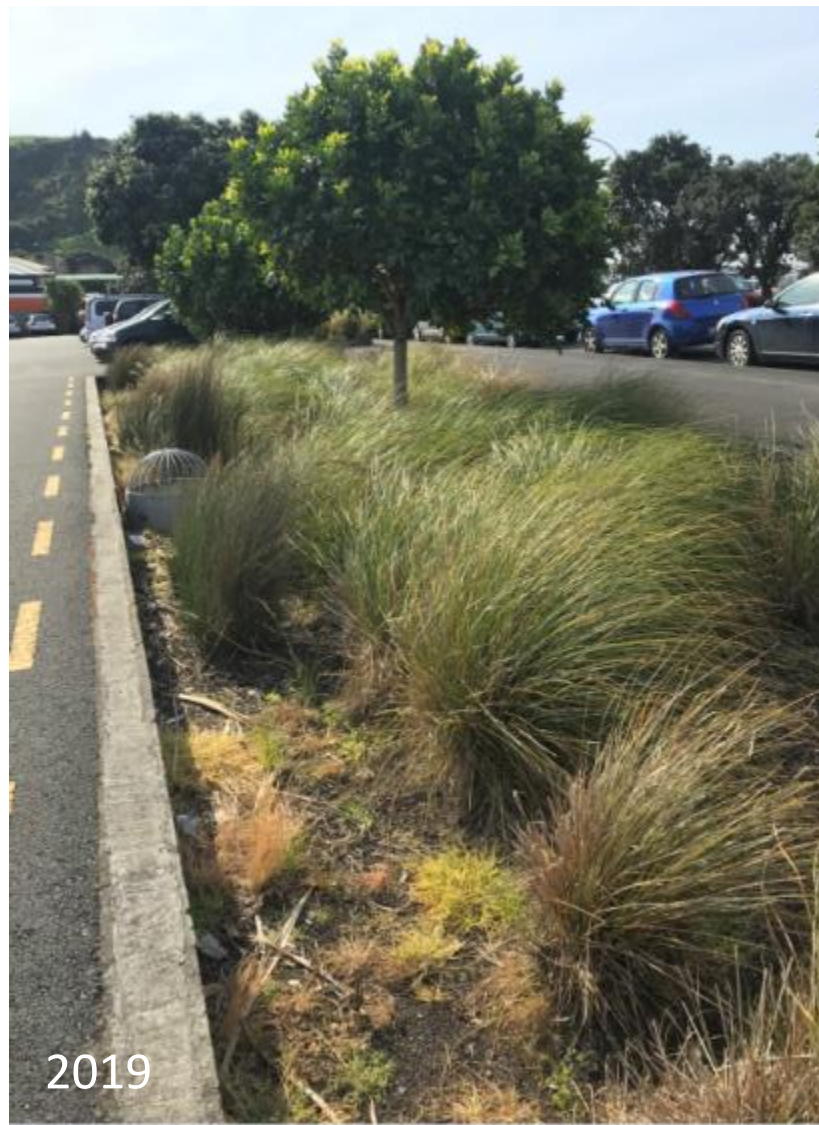
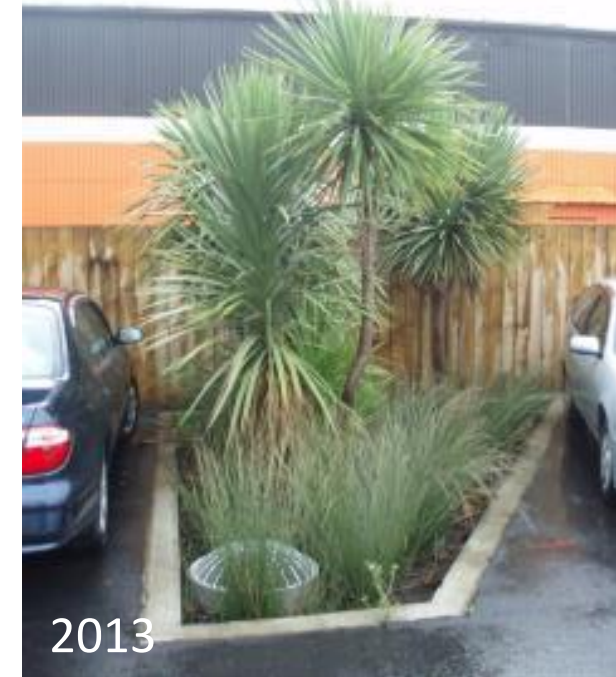
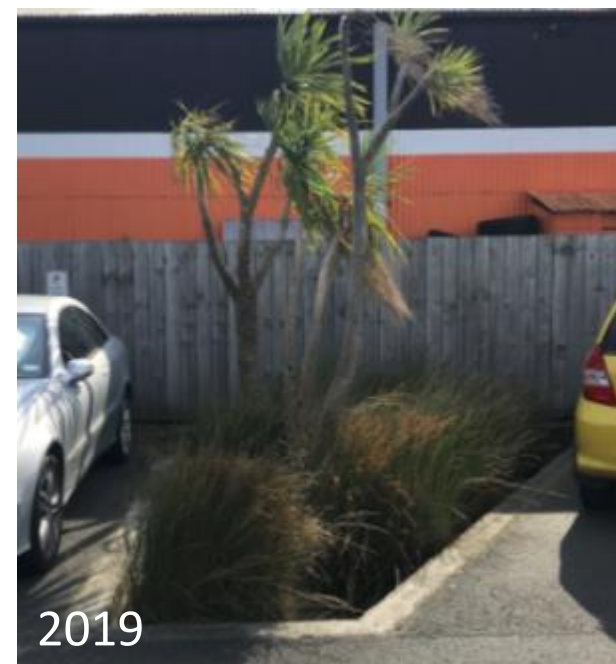
Site 5. Seamless integration of pre-existing trees within rain garden (left); location of overflow near edge allows efficient checks; bare areas should be replanted and re-mulched to avoid ongoing spraying. Right photos show expensive rain gardens – one carpark wide creates a long area of edge to maintain relative to treatment area and greater damage to trees: one larger rain garden would be more cost effective

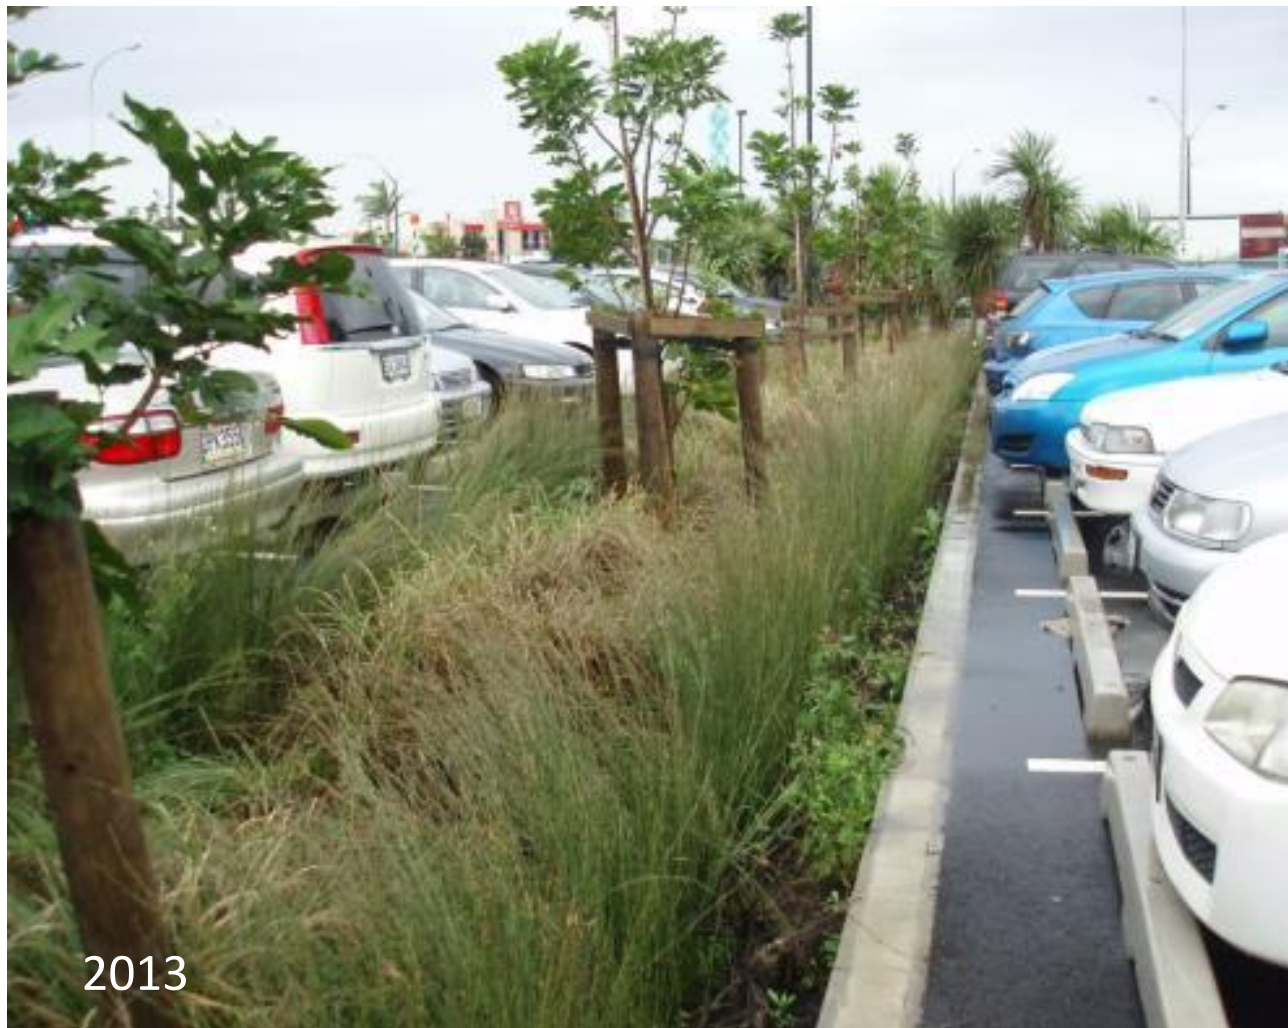
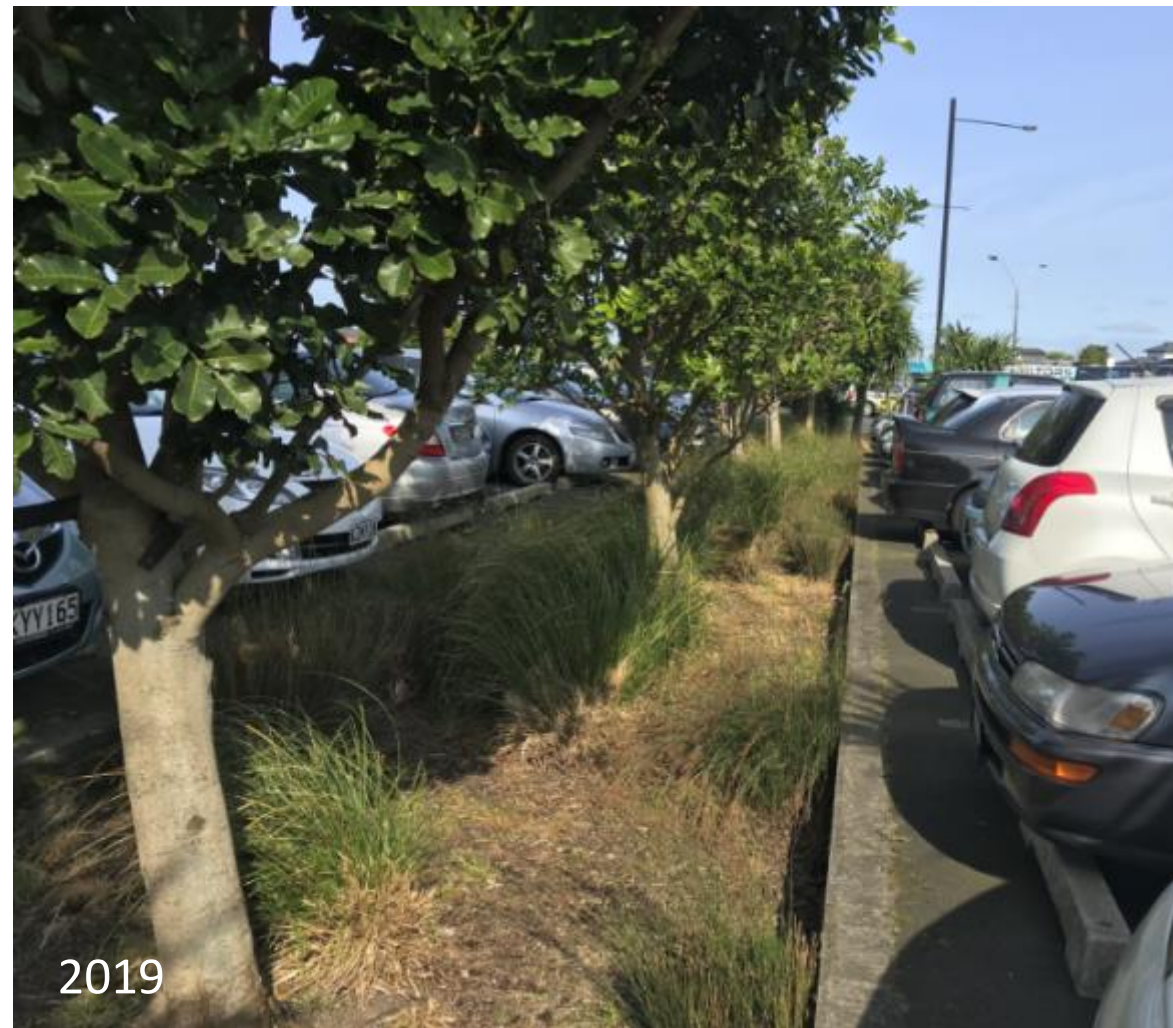
Panmure park and ride raingardens: site 5

Kohekohe trees in raingarden are generally very healthy in this media that has relatively high organic content, and are now sturdy enough to allow removal of the temporary stakes. ; Right photo shows both groundcovers (sedge and oioi) have been topped – severe topping is not suitable maintenance for oioi as it stunts and may kill it (oioi grows from leaf tips).

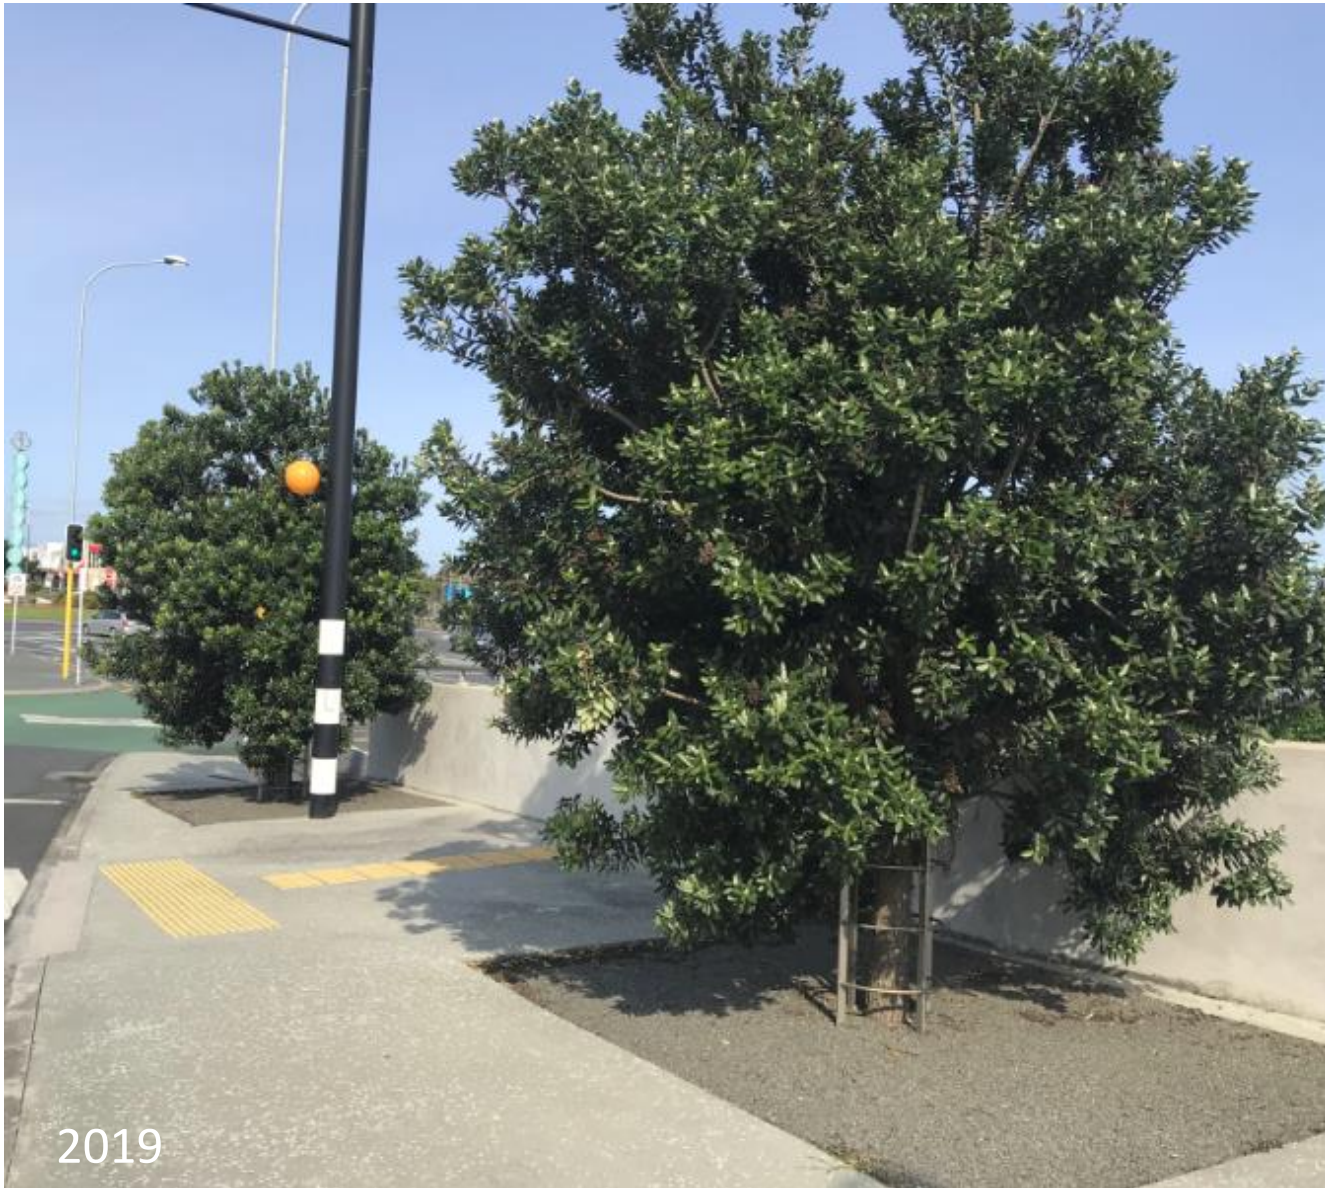
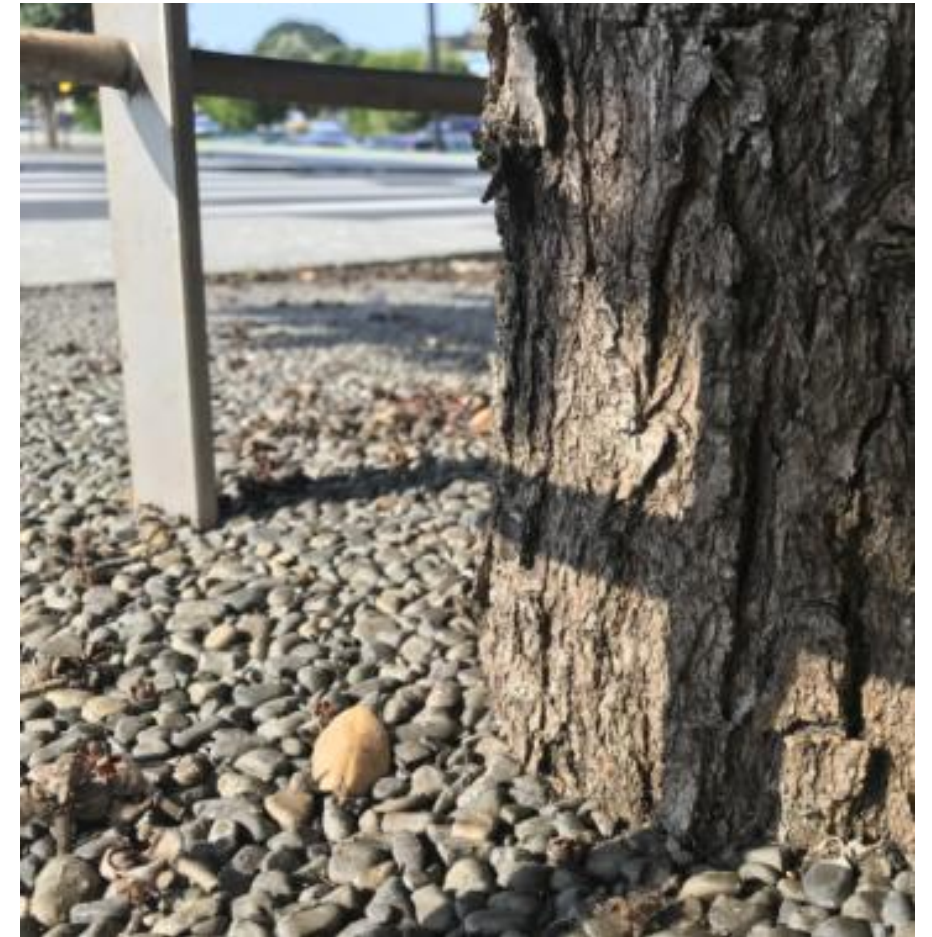
Ellerslie Highway overbridge: site 6

Site 6. Tree pits in overbridge with permeable paving (poured-in-place resin-bound pebbles). Resin must be kept away from the trunk or it 'ring-barks' the tree; use inner ring and loose gravel.

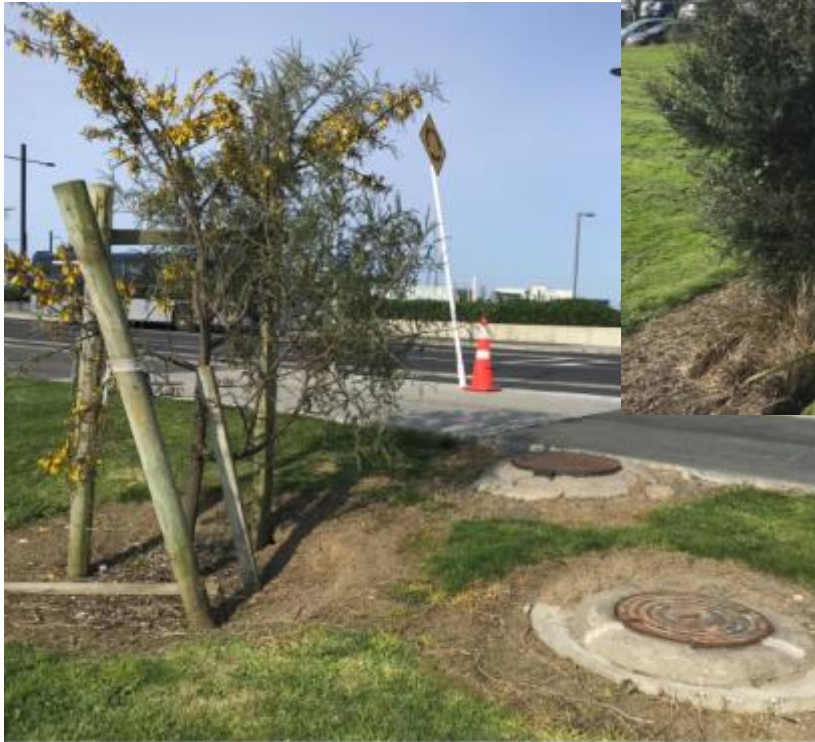
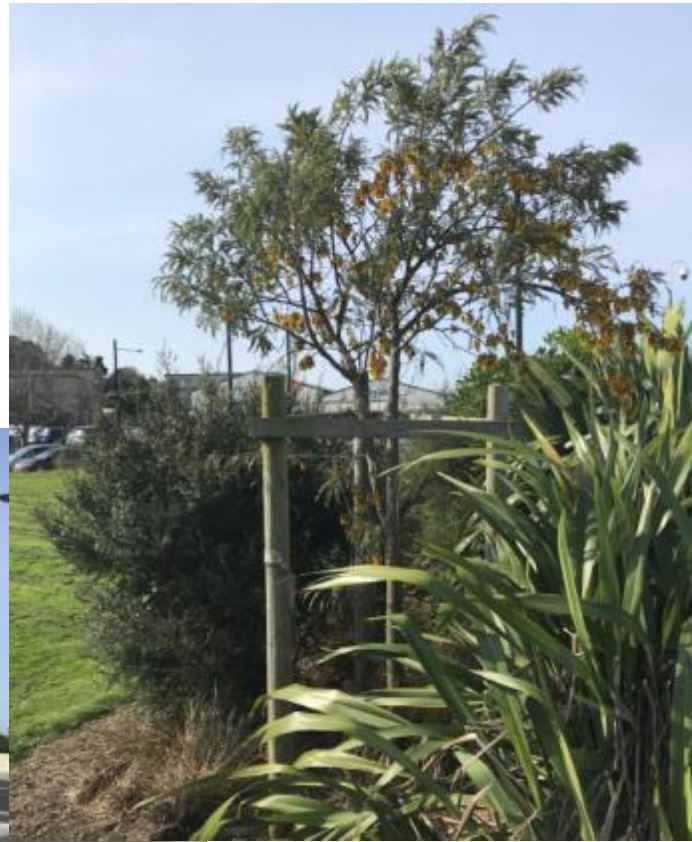
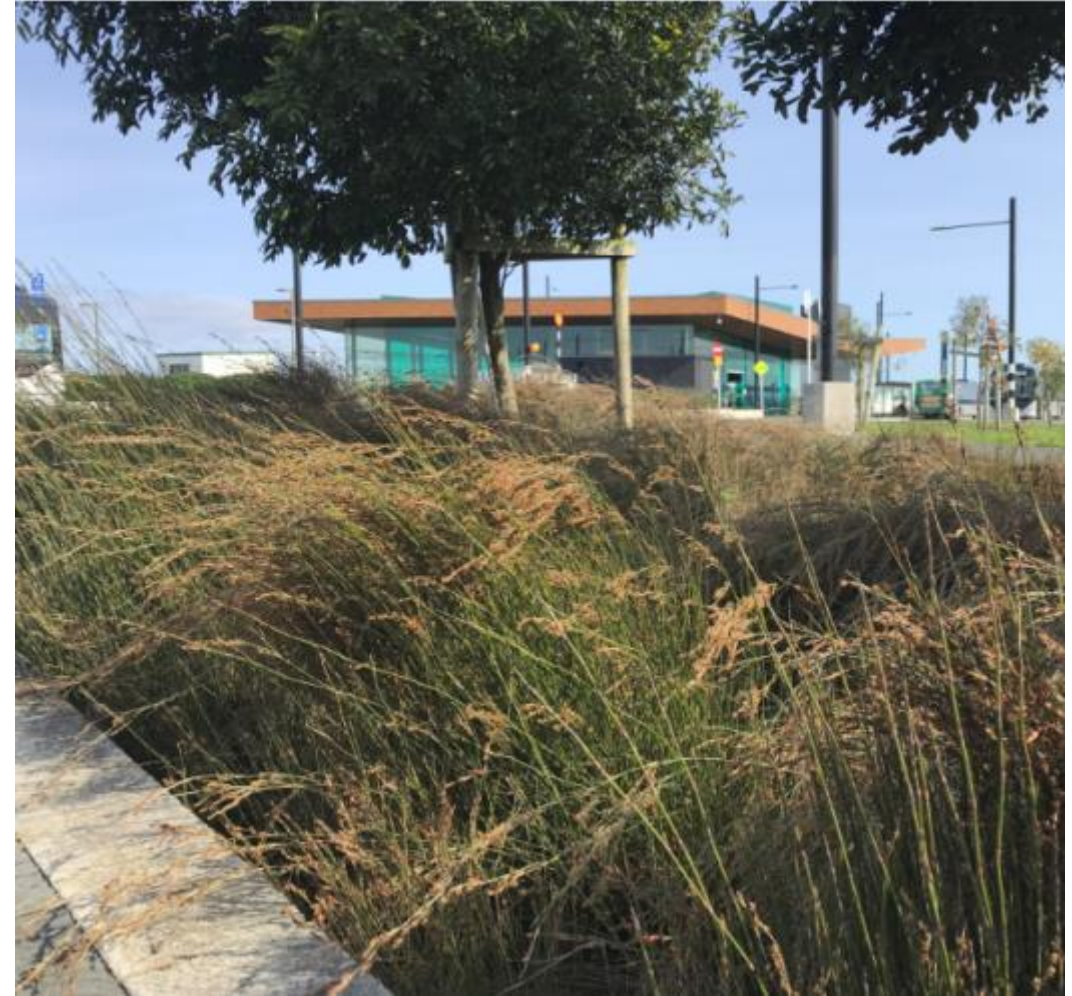
Quinlan Street: site 7

Site 7. Trees in landscaped areas with under-planting are generally healthier and much less vulnerable to damage during maintenance and from vandalism. The poles (left) are effective but ugly protection from mowers (left), as is the herbicide over-spray. In contrast trees with groundcover (centre) and in the rain garden (right) are more aesthetic. However, up-lights in the rain garden are hard to find and require additional maintenance to retain clear of plants and this also introduces potential for plant damage and weed invasion.

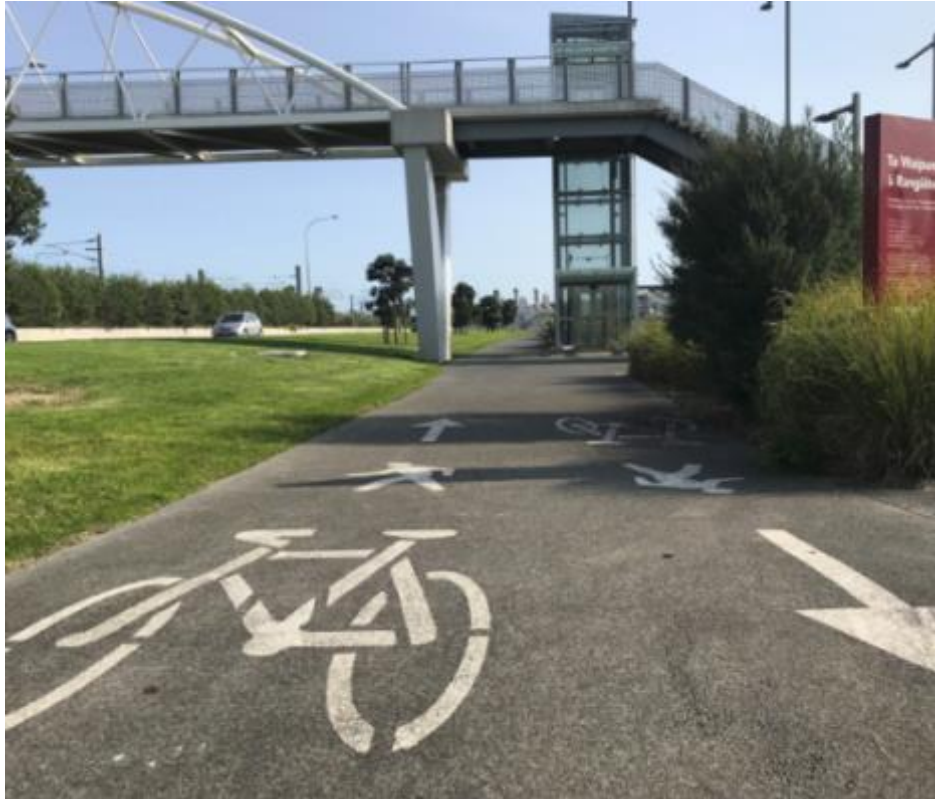
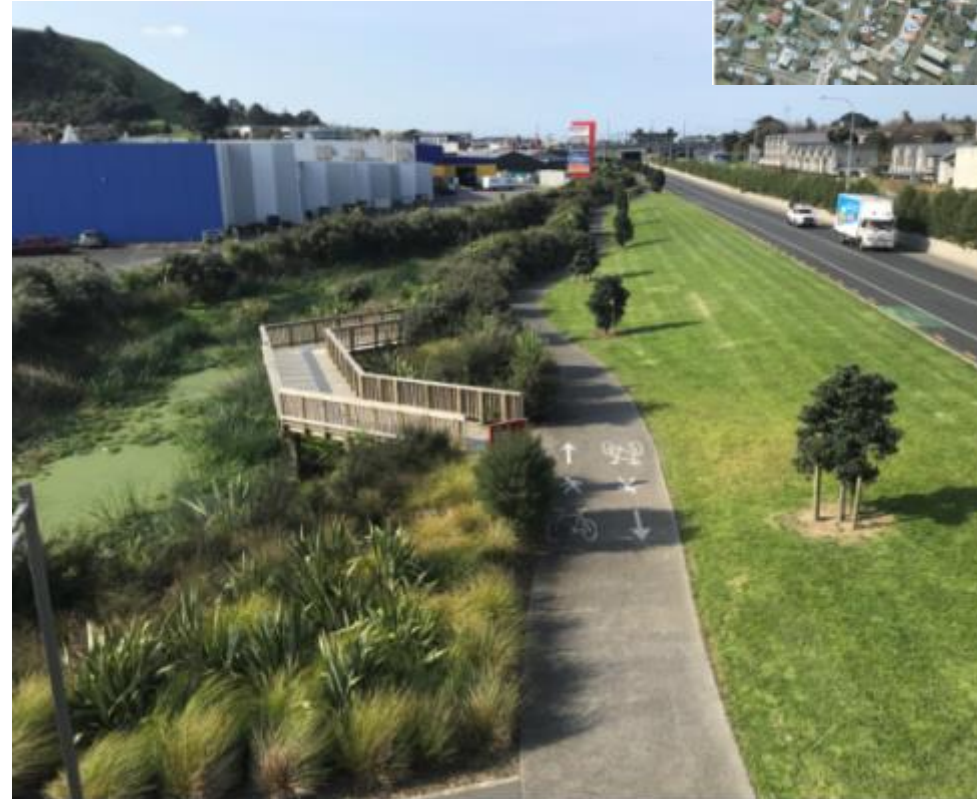
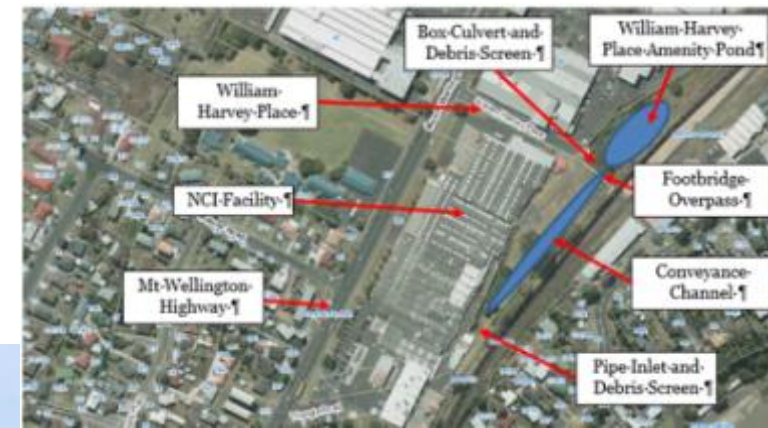
Te Horeta Road, cycle & walkway, wetlands: Sites 9 & 10 (site 8 = new soccer carpark)

Sites 9,10. Trees in grass are well protected from mowers by stakes; their placement is generally linear for efficient mowing and allowing additional traffic lane in future. Edge of short sedges (foreground) require less trimming than shrubs (background) to maintain sightlines. Dense planting and viewing structure deters access to wetland. Wetlands aesthetic and functional (high proportion of emergent plants provide plenty of opportunities for sediment settling and biotic films; little raupo. Overflow outlets are visible and grates are largely clear, unlikely to block
