AMETI, AUCKLAND WSUD WALK

Activating WSUD Project
Building better homes towns and cities science challenge

AMETI WSUD walks

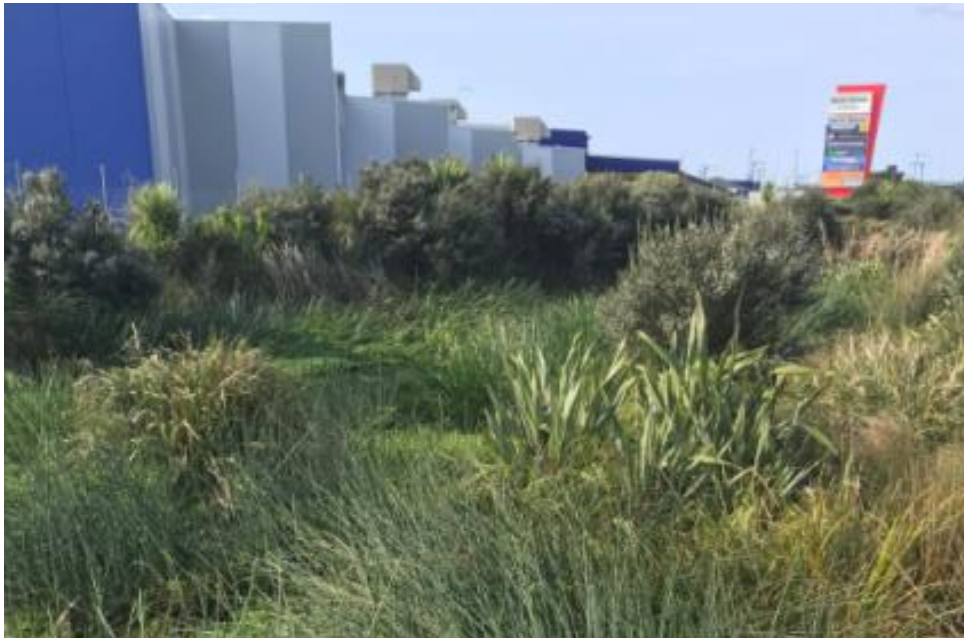
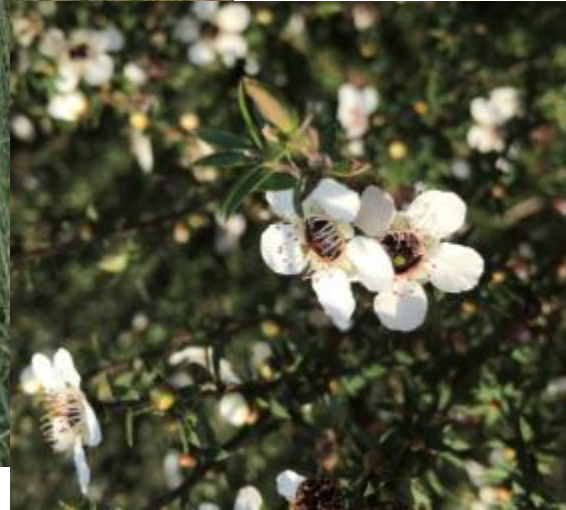
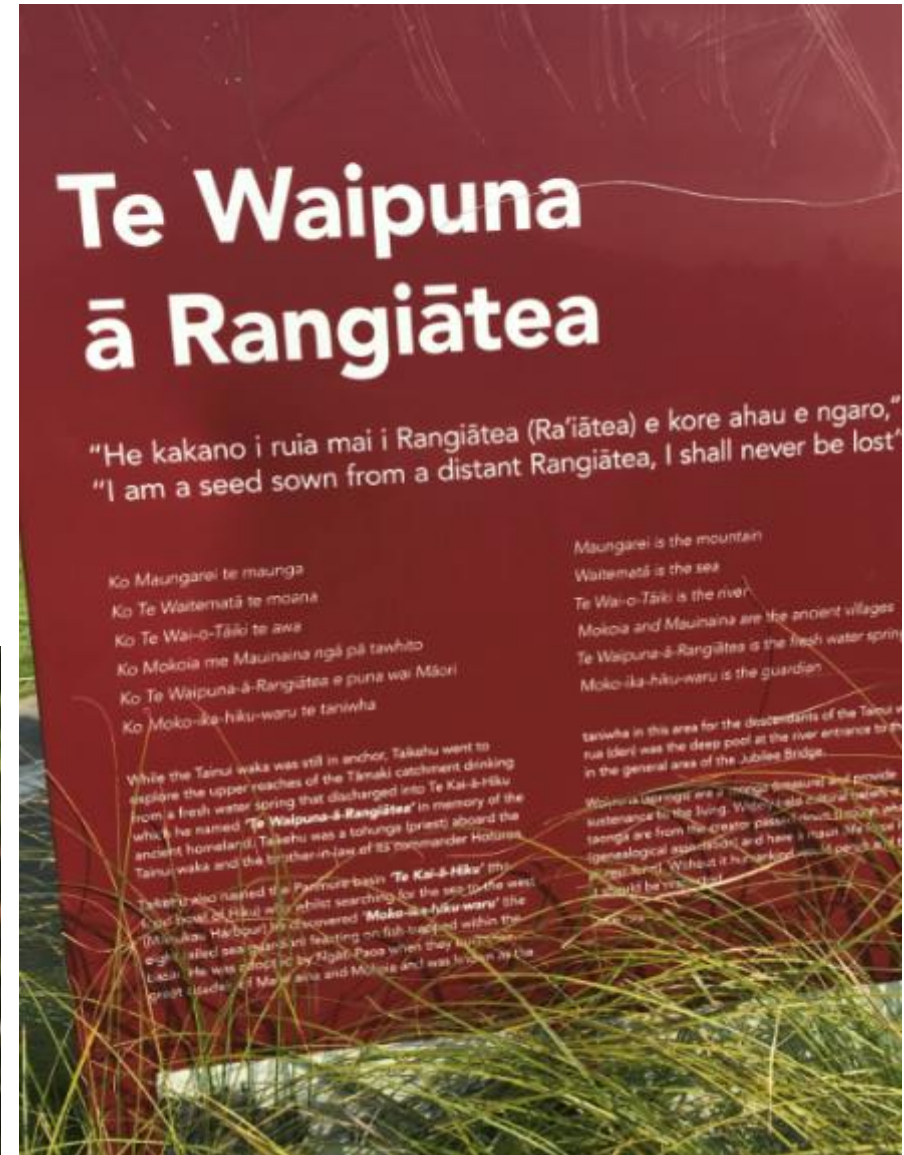
Sites 9,10. Plants are native, locally-appropriate to area. Plants are dense and tall enough (in water and on land) to exclude and resist invasion by most weeds (except moth plant along edges); manuka flowers provide food for pollinators; interpretation panel helps explain significance and cultural history

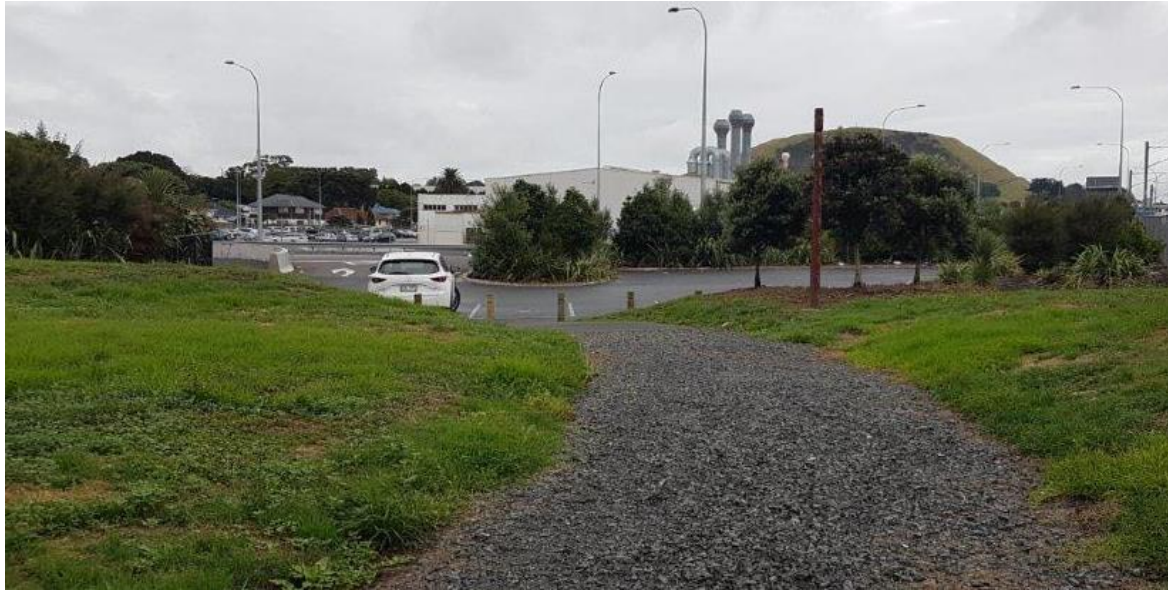
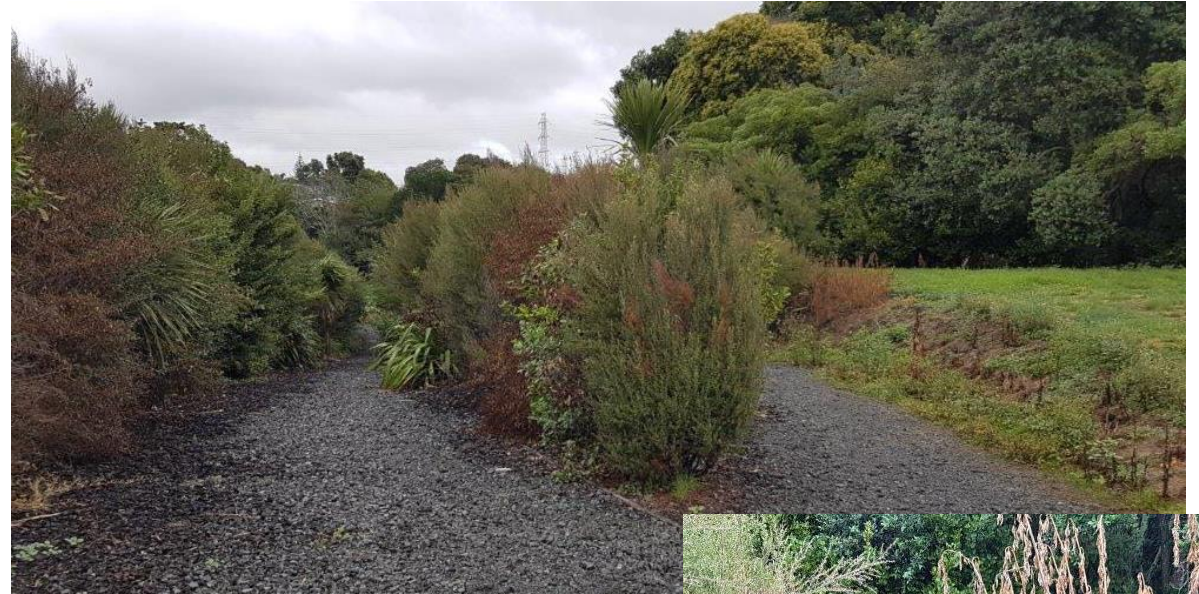
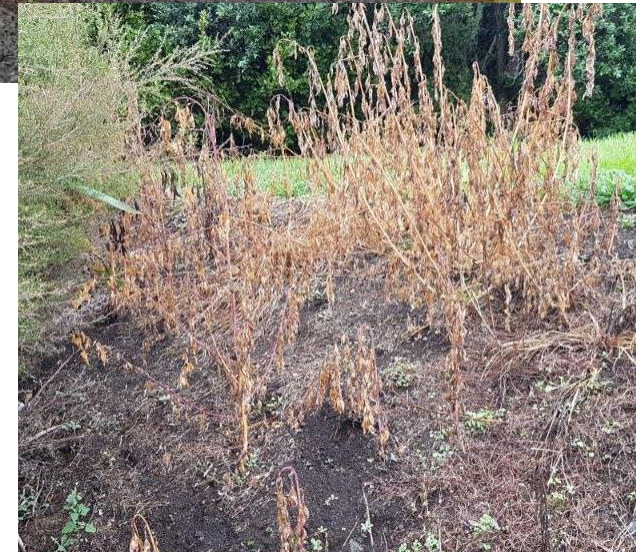
Access provided for machines to side of lagoon for sediment removal. Track is relatively narrow and now shrubs are overhanging the track (some have died with summer drought), so truck access is likely to damage plants. Due to this and probably damage to gravel surface ensure contracts have a clause requiring reinstatement (and before/after photos). Maintenance should establish a dense edge (unlikely if vegetation overhangs the path and then is severely cut back – exposing soil will allow weeds to establish).

Note steep slope to right – maintenance feature as needs continual spraying or hand-trimming – plant or rock mulch to decrease cost

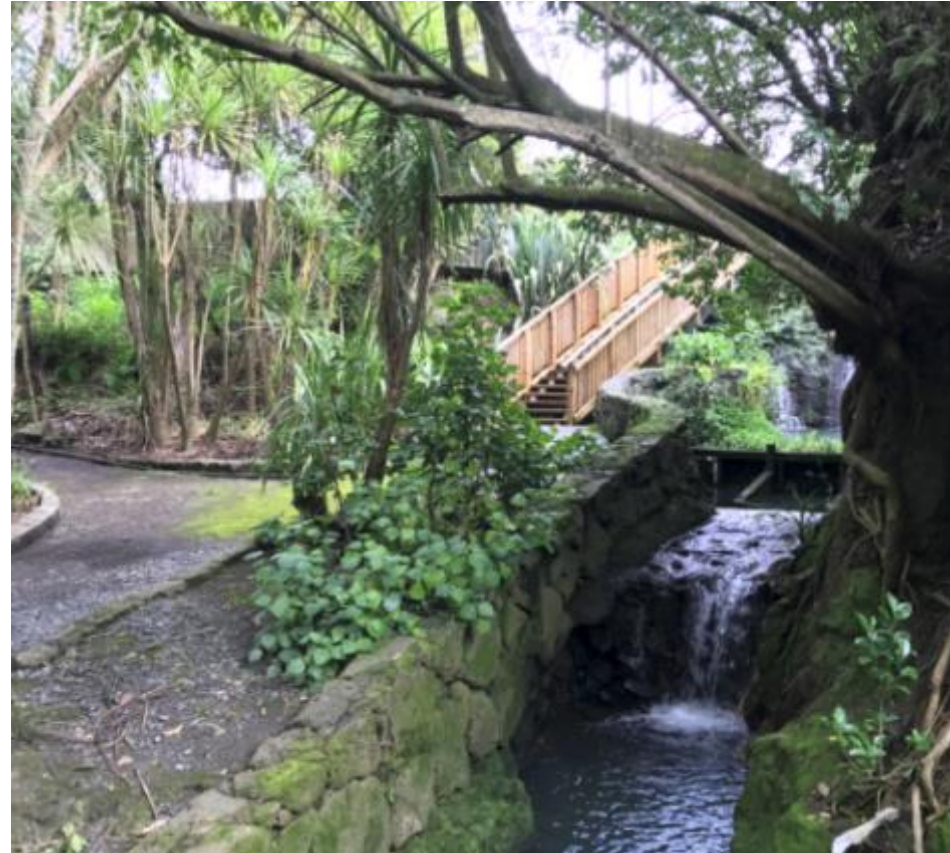
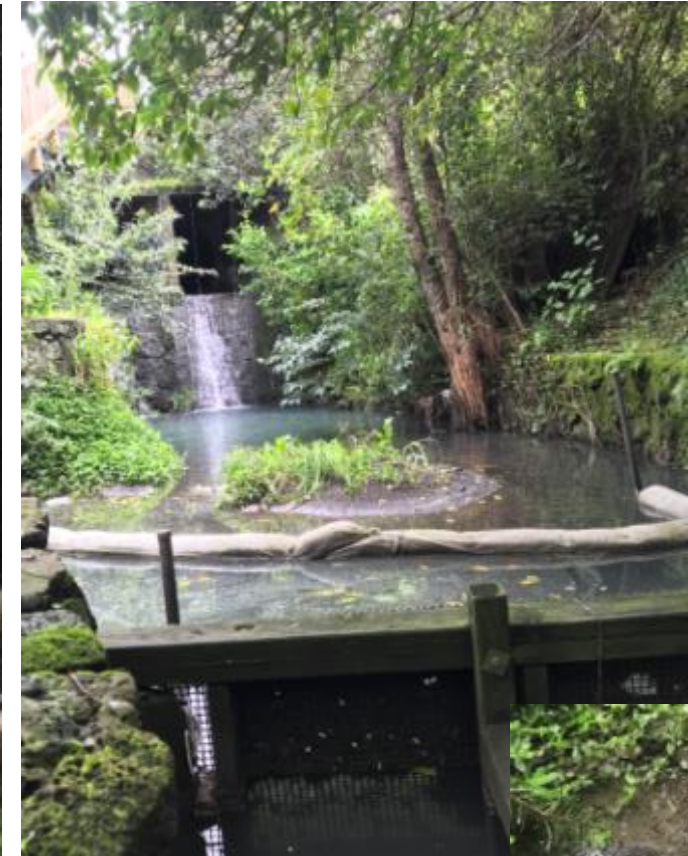
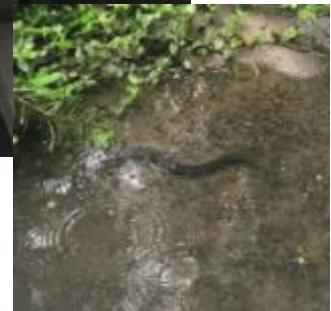
New inlets. Left with enhanced energy dissipation (out of sight under the bridge, along with an oil & grease boom present in March 2019); Right & top: inlet with litter screen that has bypass flow exacerbated by accumulation of sediment stabilised with vegetation (indicating inadequate frequency of maintenance). A little (25 cm eel) was seen in the pool below this inlet.

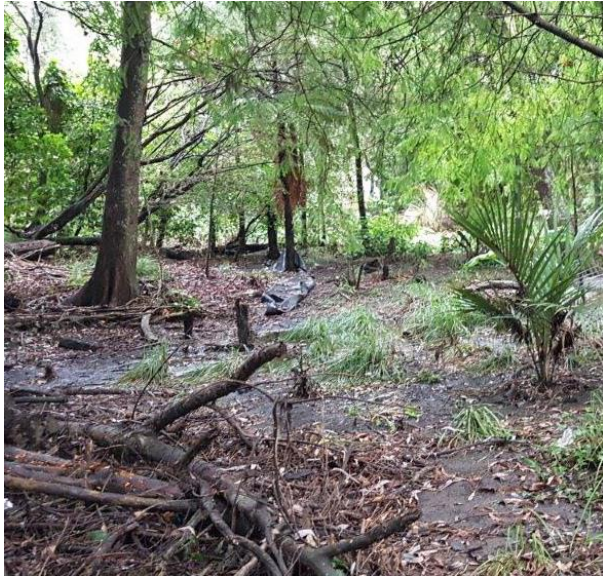
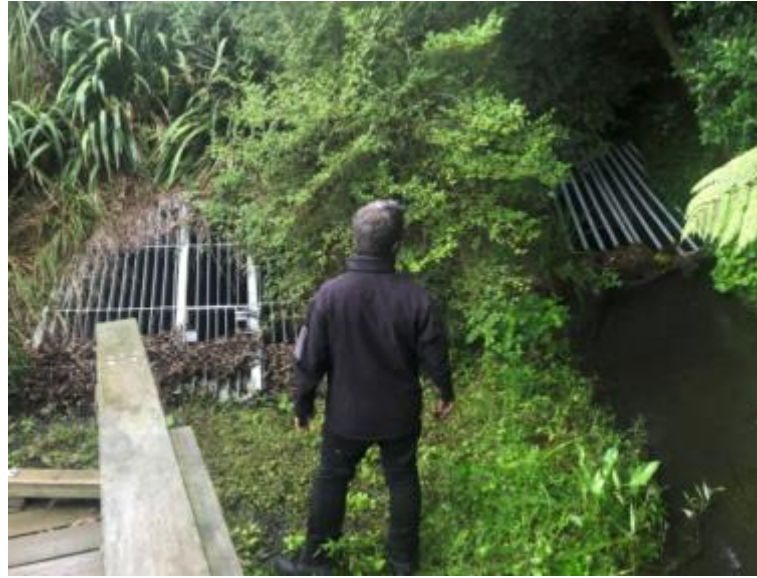
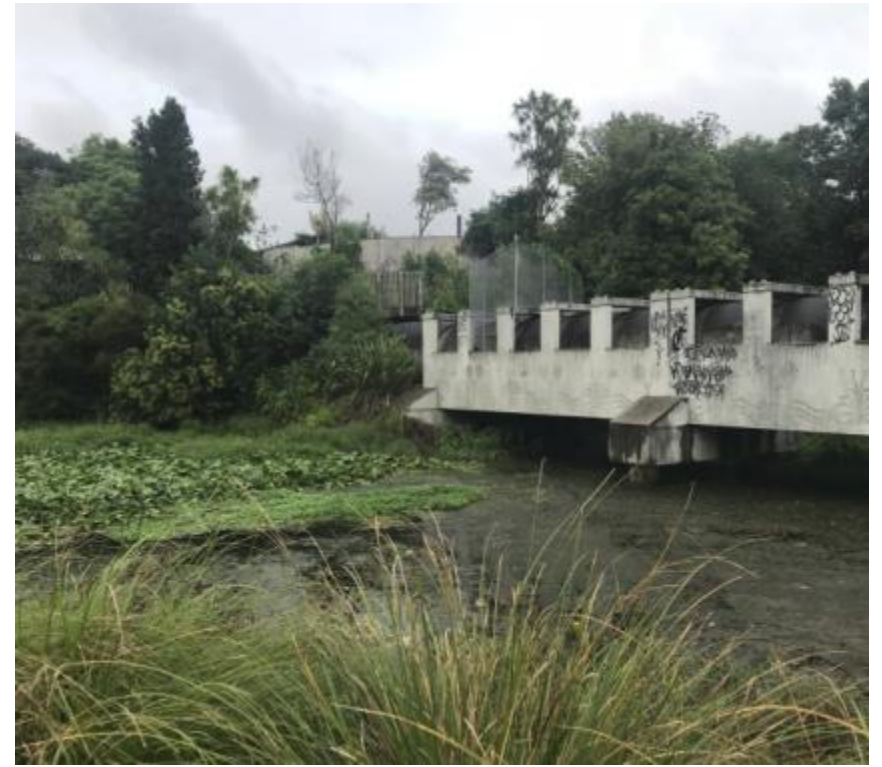
Van Damm's Lagoon and outlets

Outlets. There is high potential for blockage due to the large trees (and dead wood) in the catchment. Debris removal from the overflow grates is important. Adding a second overflow provides backup. The original grate (right) is a 1.52 m diameter ach culvert with screen that has some very broad 'gaps'; the new grate is has a smaller surface area as it is relatively small and steep relative to the diameter of the pipe.

The sewer pipe has been encased, reducing visual impact. Somehow taggers have accessed this and sprayed graffiti in places where it is really difficult to remove. A locked gate to enable access to the top of the pipe would allow removal of the graffiti. It provides a shag perch.

Very high energy flows keep inlets and narrow section of stream clear, the sediment is deposited as soon as flood-water can spread laterally – under canopy of forest. If sediment backs up, it will fill the lovely clear channel and remove habitat, potentially also smother the trees.

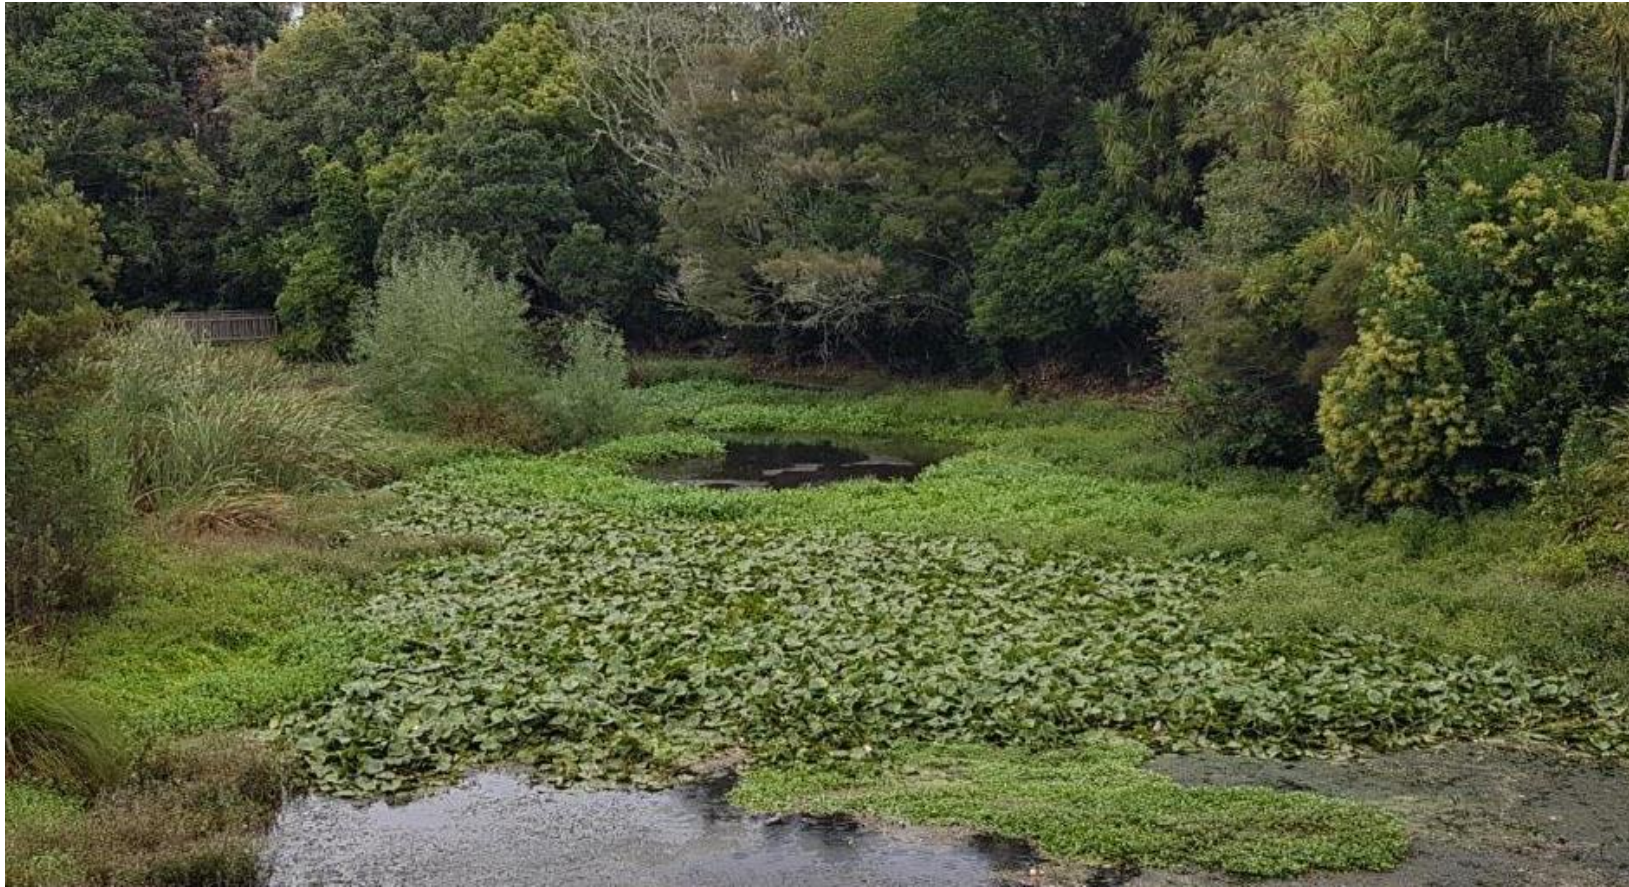
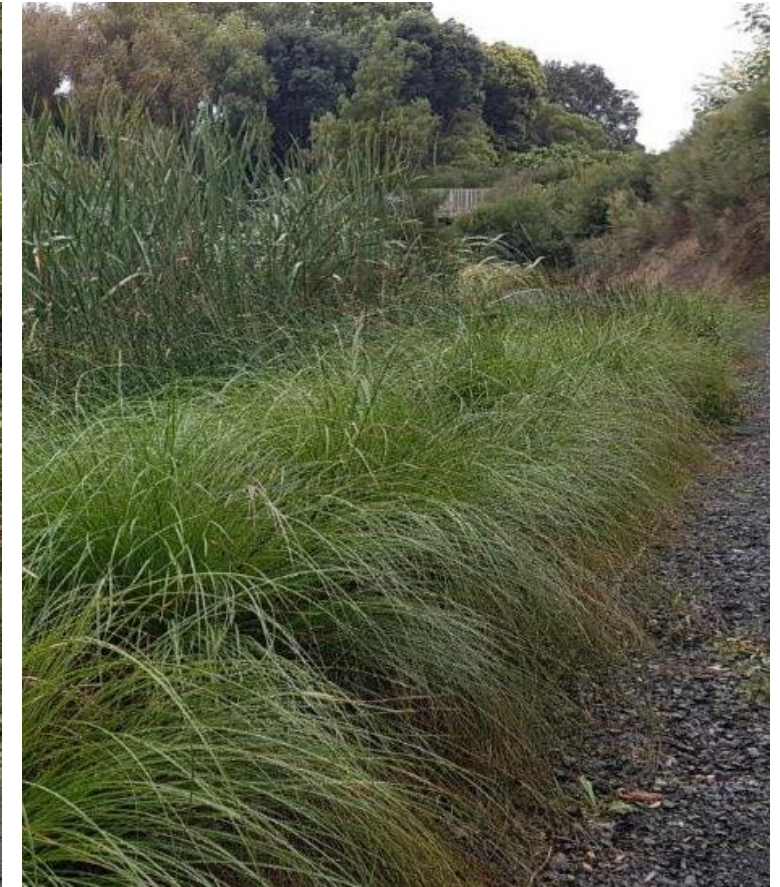
Van Damm's Lagoon

By April 1 2019 the lagoon appeared full of sediment again; pest plants established in the sediment included new willows (up to 4 m height). Removal back to the 1-1.5 m depth volume will cost \$X00,000 – unless sediment is pushed through to Panmure Basin in a big storm (this photo was taken in late March 2019, with the last large storm event being Christmas 2018). Dewatering is difficult because the area is online and large.

Surrounding landscaping has some beautiful established and ecologically valuable trees, and recent planting is generally very healthy – but some pest weeds are well established (privet, moth plant, acacia, castor oil plant). The recent drought resulted in death of some 3-4 year old plants (mainly karamu and manuka). The lagoon has raupo and native rushes along the true LHS, retained as habitat

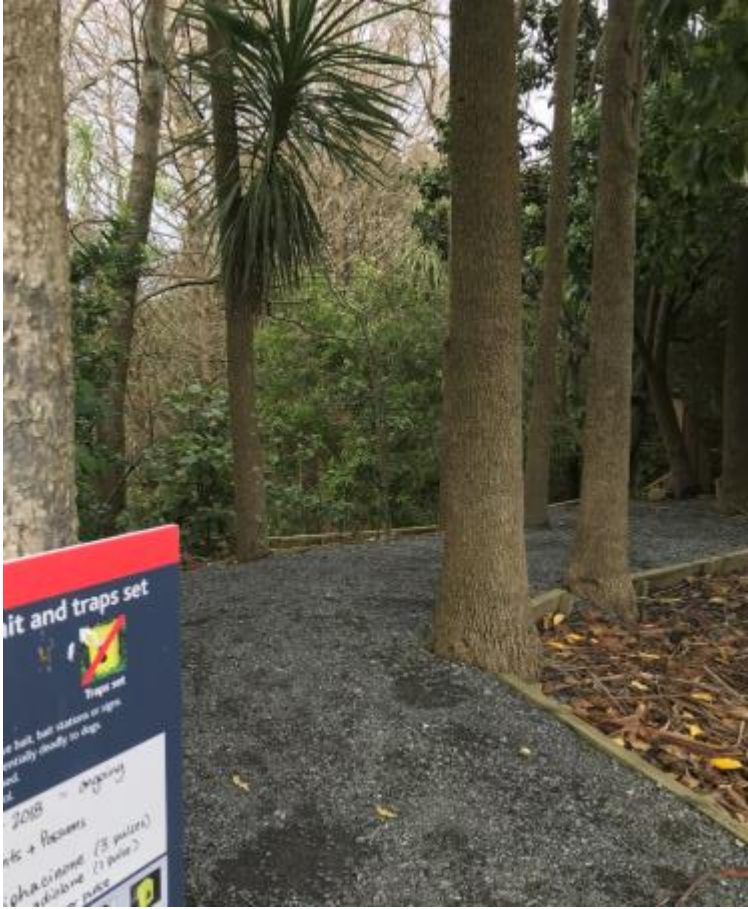
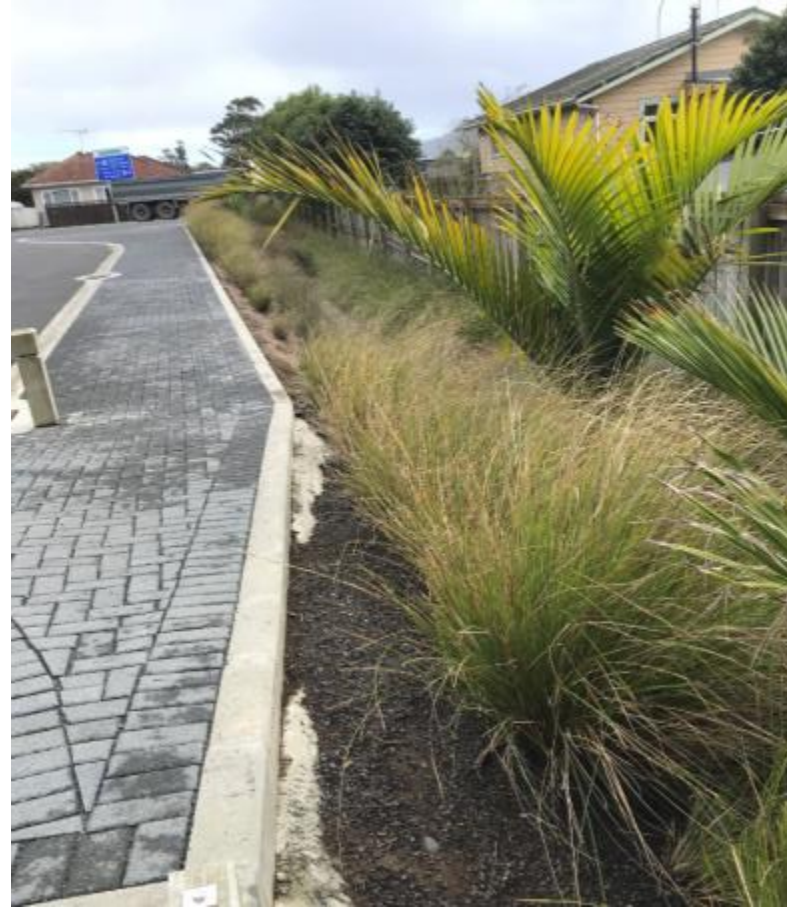
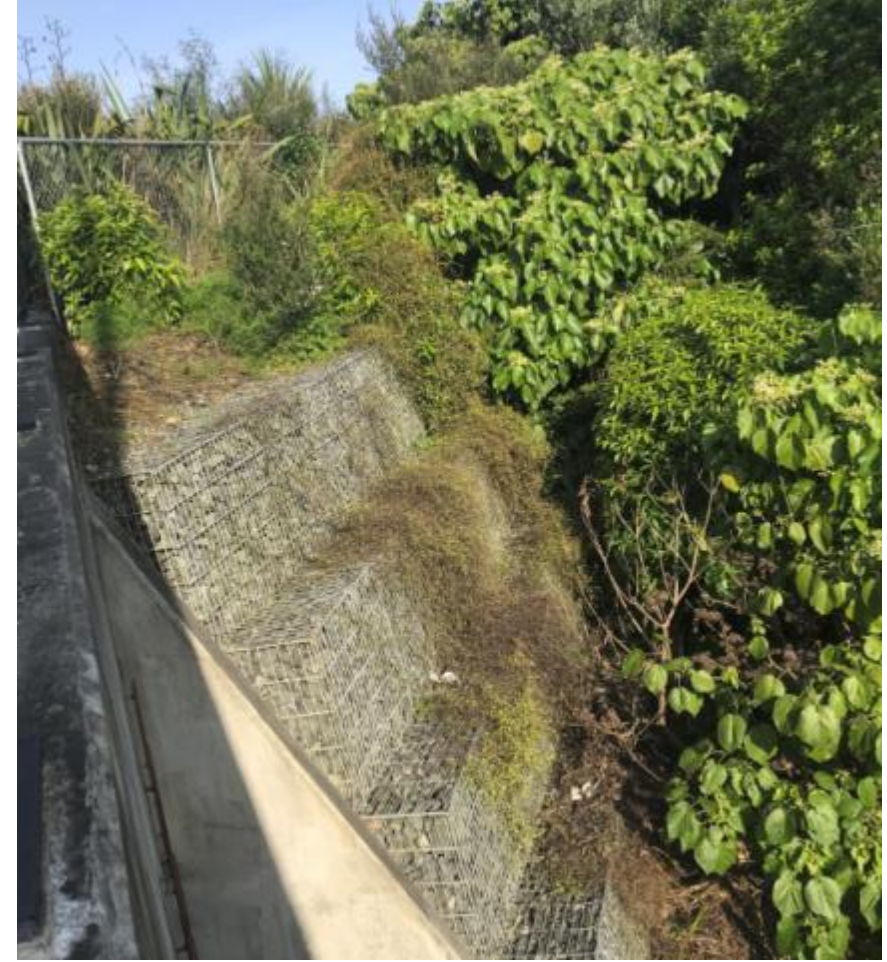
Van Damm's lagoon: Mt Wellington highway entrance

Entrance to Van Damm's lagoon uses permeable gravels and avoids removing existing trees (ti kouka, cabbage trees); undergrowth is removed to improve views and safety (left); low maintenance swale uses native sedges (centre); native pohuehue grows over and visually softens the gabion wall, providing potential cover and food for native lizards (right)
