AMETI, AUCKLAND WSUD WALK

Activating WSUD Project
Building better homes towns and cities science challenge

AMETI WSUD walks

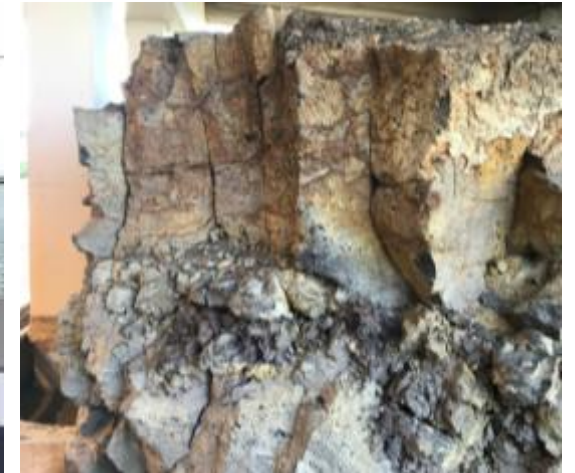
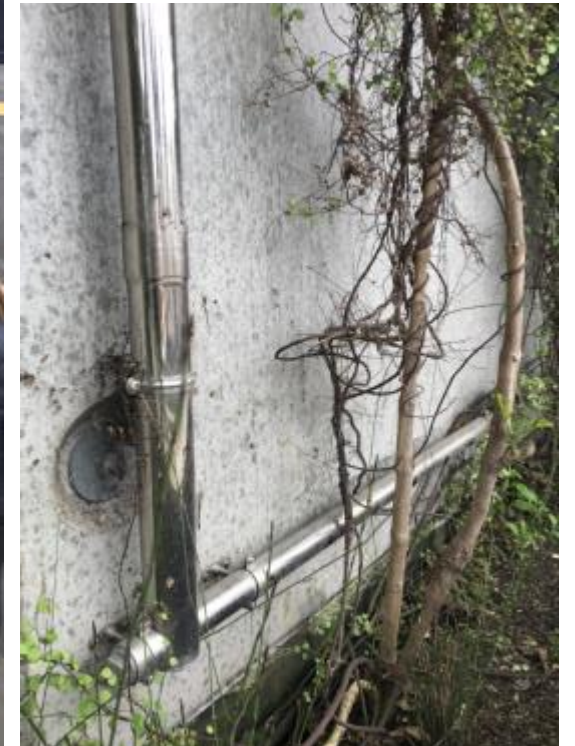
Site 1. Stormwater planter green screen

Lava geological feature

Irrigation detail

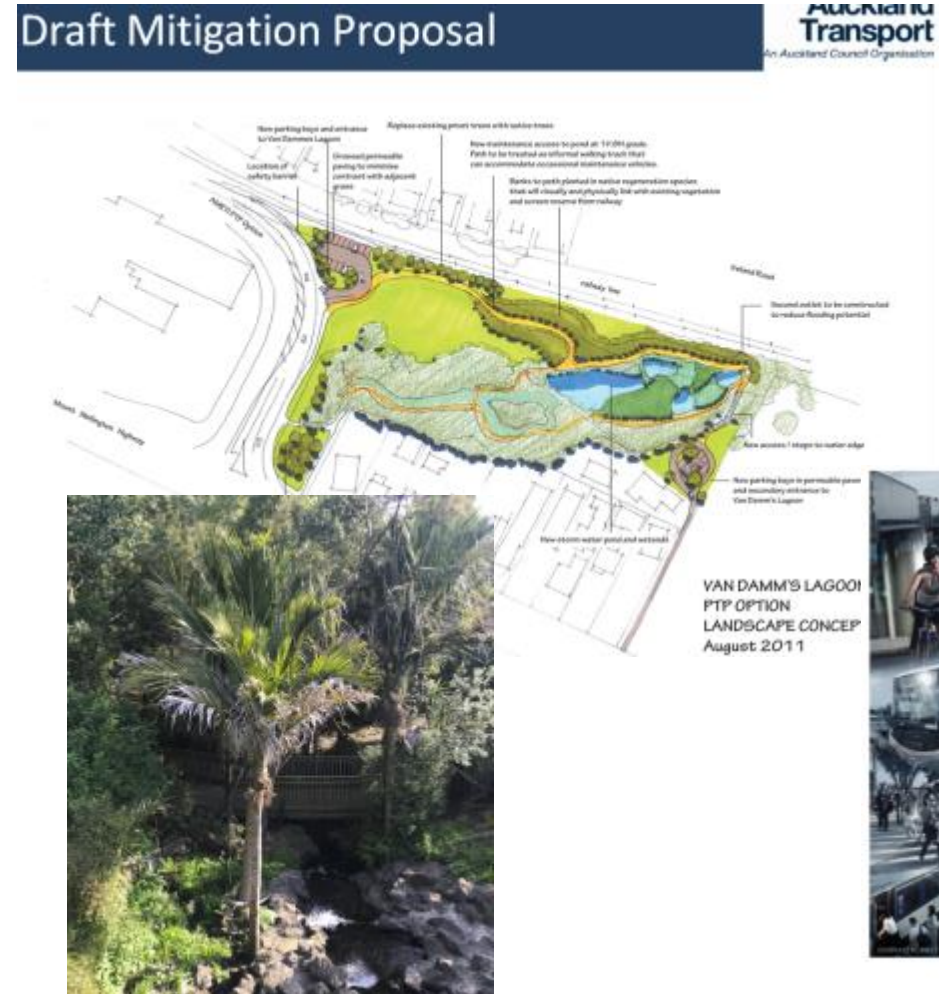
Te Horeta Road entrance to Van Damm's Lagoon

Access provided for machines to side of lagoon for sediment removal. Track is relatively narrow and now shrubs are overhanging the track (some have died with summer drought), so truck access is likely to damage plants. Due to this and probably damage to gravel surface ensure contracts have a clause requiring reinstatement (and before/after photos). Maintenance should establish a dense edge (unlikely if vegetation overhangs the path and then is severely cut back – exposing soil will allow weeds to establish).

Note steep slope to right – maintenance feature as needs continual spraying or hand-trimming – plant or rock mulch to decrease cost

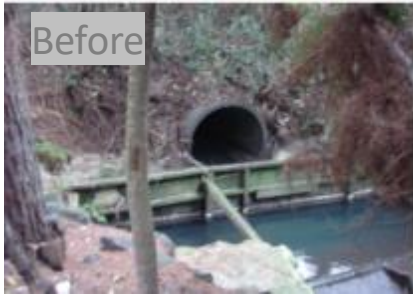
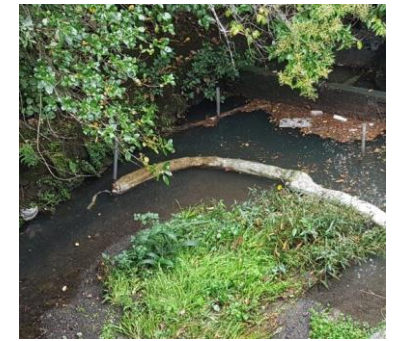
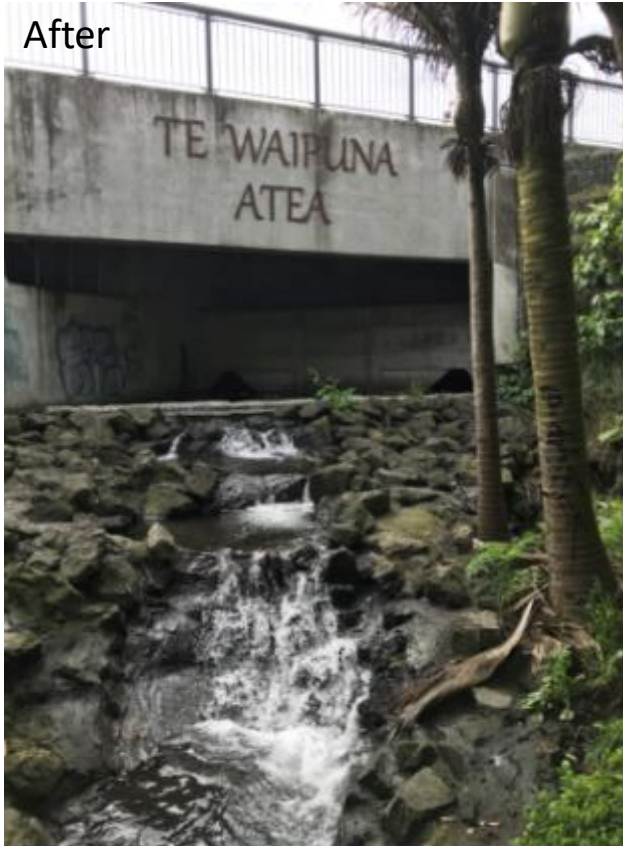
Van Damm's Lagoon inlets

New inlets. Left with enhanced energy dissipation (out of sight under the bridge, along with an oil & grease boom present in March 2019); Right & top: inlet with litter screen that has bypass flow exacerbated by accumulation of sediment stabilised with vegetation (indicating inadequate frequency of maintenance). A little (25 cm eel) was seen in the pool below this inlet.

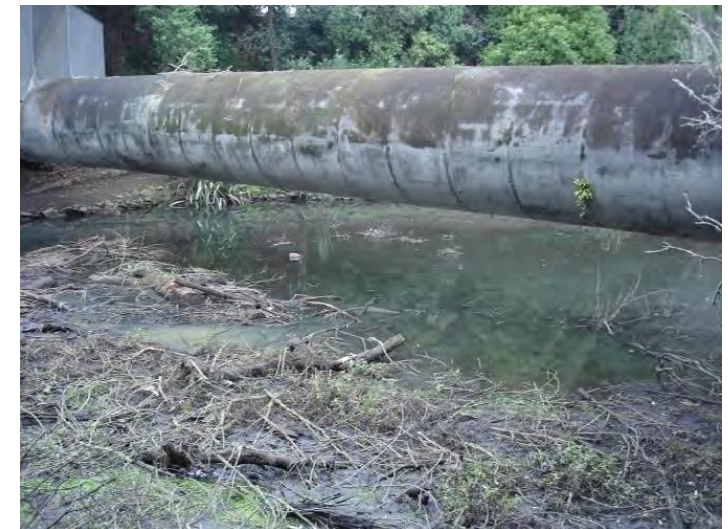
Eastern interceptor prior to AMETI

The sewer pipe has been encased, reducing visual impact. Somehow taggers have accessed this and sprayed graffiti in places where it is really difficult to remove. A locked gate to enable access to the top of the pipe would allow removal of the graffiti. It provides a shag perch.
