Talbot Park

Case Study Researchers: Kathryn Scott & Robyn Simcock, Landcare Research, July 2007

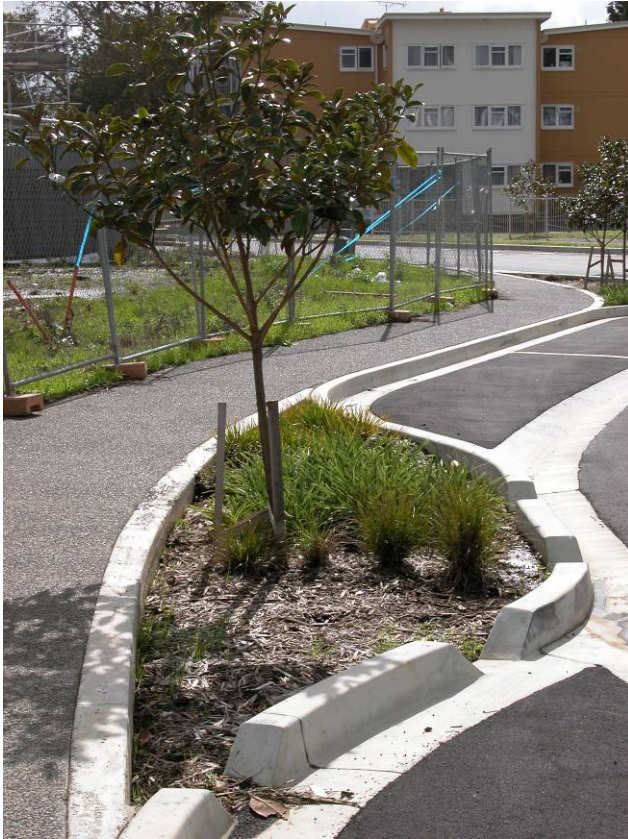
Rain gardens were designed to help slow traffic and provide visual amenity to Talbot Park, as well as detain and treat road runoff. Evergreen magnolias and native groundcovers of sedge, mountain flax and NZ iris were planted. Photo: May 2006, soon after construction.

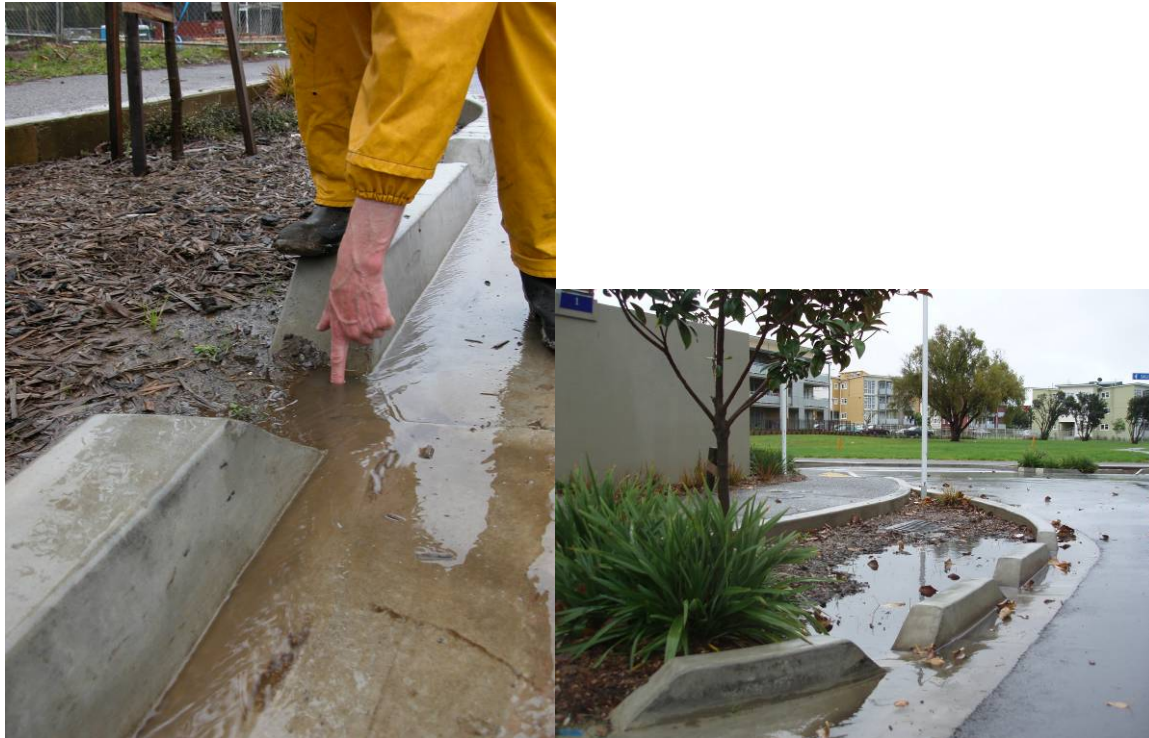
During construction of houses, sediment eroded from the building sites was captured in some rain gardens until it prevented water flowing into the rain gardens (left photo, July 2006). Most rain gardens were constructed with less than the specified 220 mm ponding depth, generally due to a combination of overfilling of the raingarden with soil and mulch, and the overflow grates being set too low. This means in places stormwater can short-circuit the raingarden, reducing treatment efficiency and volume detained (photo July 2007)

- Rain gardens: Allow live storage of 220 mm. Sheet flow is required for rain gardens to function well; barriers can be pinned above the ground as an alternative to curb and channelling. Rain gardens should be completed after buildings. If raingarden underdrains and gravel/sand layers are completed before buildings are started, they can be covered with filter cloth, and used to trap sediment during construction. After houses are finished, this filter cloth and overlying sediment should be removed and raingarden tilled, planted, and mulched. Rain gardens should be mulched with a non-floating organic mulch (e.g., long-fibre chip). Signs can be useful to inform people about the purpose and requirements of the rain gardens (photo).
